# Monitoring results of Malaysian Building Integrated PV Project in Grid-connected Photovoltaic system in Malaysia

**Abstract** This paper presents the current status of the grid-connected photovoltaic (GCPV) system installed in Malaysia. There are 113 sites with total PV capacity power, of 1008.73 kWp GCPV systems are monitored by the Photovoltaic System Monitoring Centre (PVSMC). This paper focus on the PV system performances under Malaysian Building Integrated Photovoltaic (MBIPV) project which relates the performance of the system failures due to technical and environmental factors. Both factors will contribute to the reduction of the PV system performances in terms of final yield. It would later lead to energy inefficiency as the energy harvested from PV array will be wasted which later cause the time taken for energy payback period of the system to be lengthen. Proper and sufficient practical knowledge in designing a GCPV system is needed in order to achieve maximum energy production. A database with minimum period of 4 years was selected as the benchmark for problem identification at PVs site in hot and humid climate. All issues affecting the system performances and BOS com

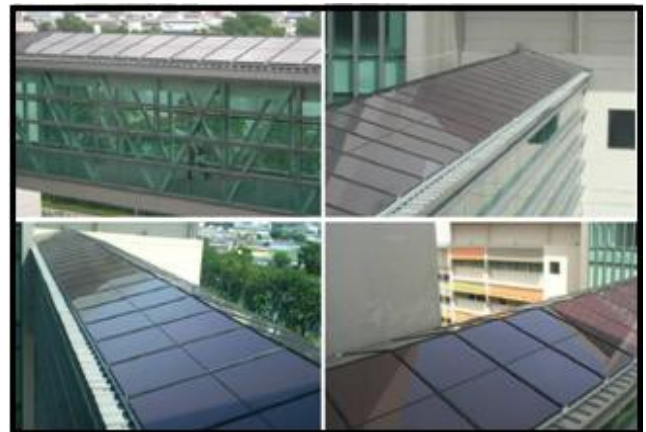
**Figure 8.** Monash University, Sunway Campus, Malaysia[3]

tages of thin-film modules, however it should still be unshaded. Generally, the shadow on PV array's surface is usually caused by trees, houses or building in the neighbourhood that may fall at part of area or only for a relatively short time. So, it is very important especially in hot and tropical climate to determine the direction on the sun movement to ensure the various object such as trees, houses or building will not shade the PV array's surface. One site was took as a case study that affected by shading problem as shown in Figure 8 and the site description was depicted in Table 1 below.

Figure 9 shows the final yield values had decreased significantly from November 2007 until April 2009 (red) after two years the system was commissioned. The system was operated in a low condition in terms of final yield performance over the monitored period. In addition, it can be seen that the reduction pattern on the final yield performance at Monash University was caused by building shading.

direction[5]. The installer requires to be familiar with the sunpath diagram to estimate the percentage of shading will be occurring and be able to use the Solar Pathfinder equipment to identify possibilities shading at the site before any installation to prevent this shading problem. The appropriate sunpath diagrams selected should be matched with latitude at the specific location. Typically, the latitude in between 4° to 8° N is widely used in Malaysia. Other than that, the PV installer needs to determine the solar resources at a particular site, e.g. how much of the solar available at the site, an inclination angle of the PV array is tilted, and the suitability on the PV array oriented either in South, North, East or West in order to obtain the highest energy harvested and lastly, identify the possibilities of any shading will occur after PV array had installed. Figure 10 below illustrates the components of Solar Pathfinder™ equipment such as tripod, sunpath diagram, dome with lens, compass, etc.

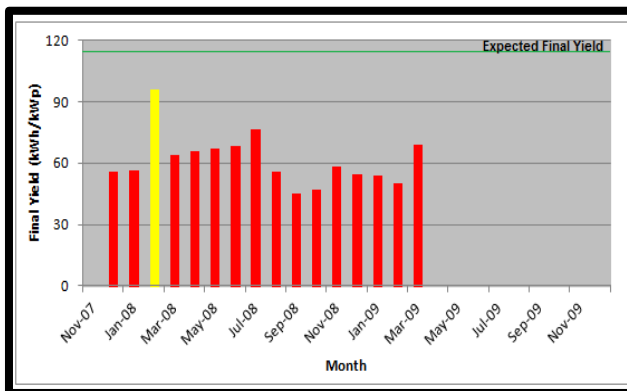
**Figure 9.** Monthly profiles of final yield generated by 7.36 kWp GCPV system in Monash University, Sunway Campus Malaysia[3].

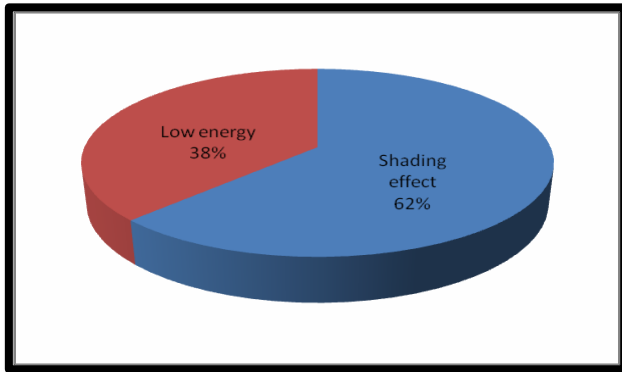
**Figure 11.** The percentage of environmental issues under MBIPV project over monitored period

There are 9 problems shows the influence on the GCPV system performances under MBIPV project over the monitored period around Malaysia as summarized in Table 5 below. About 62% of the environmental problem due to the shading issue whereas another portion was recorded on the lower energy crisis was 38% with 6 cases were reported. In contrast, there are 7 problems were involved in technical issues such as inverter shutdown was approximately 25%, as well as PV meter not accessible was 25%, and other failures (inverter defect, datalogger/sensor, SPD and site renovation). The majority problem was occurred in the system failures about 30% of the portion in technical issues during the PV performances monitoring done by PVSMC.

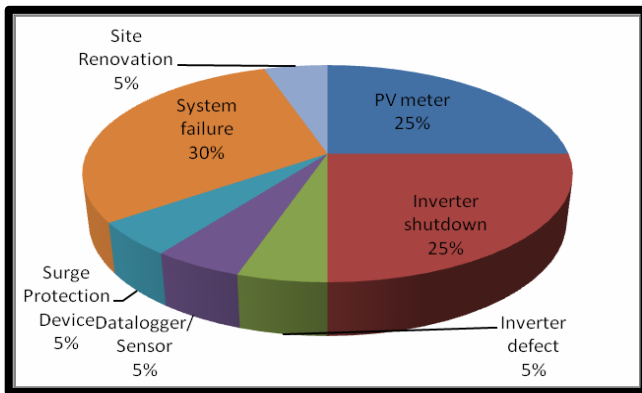
**Figure 12.** The percentage portion of technical issues under MBIPV
