Repair Methods Indication for a Timber Coverage Structure Located in Sinop City - Brazil

In the middle of this scenario, the study by proposed case was held in the Central-West region of Brazil, State of Mato Grosso, in the city of Sinop, specifically covering structure of Sinop Forest Park (11°50'5.5" S; 55°30'4.2" W). The main objective was to identify and to diagnose the nature and types of causative agents of pathologies instituted in the structure under study and, subsequently, to suggest appropriate methods curative and preventive (prognosis) to promote an increase in lifetime of the structure.

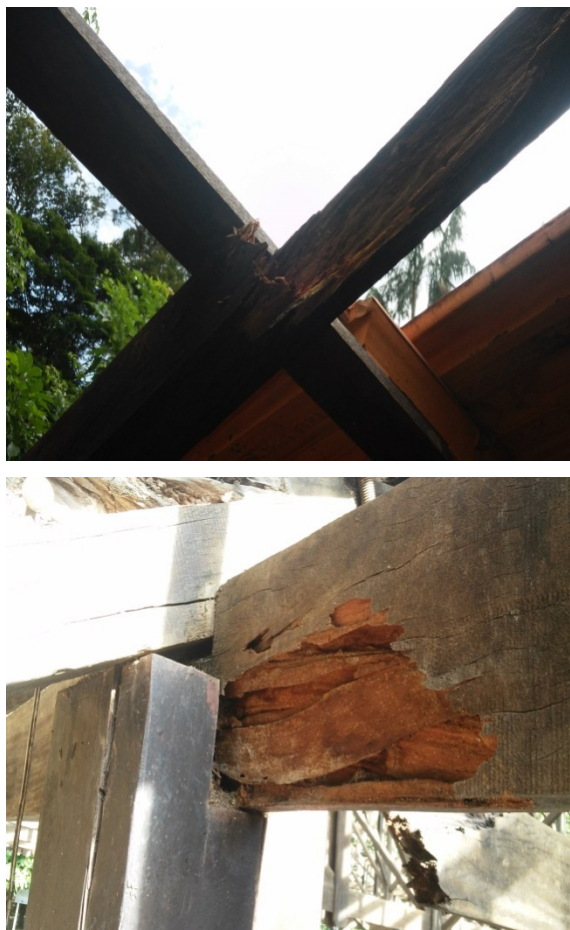
Inspection: deterioration by biotic agents - wood decay organisms (termites).

Diagnosis: pieces (rafters, girders and lattice bars) damaged by termites, due to lack of periodic preventive maintenance (fig. 2).

Figure 2. Pieces (rafters, girders and lattice bars) degraded by the action of termites

Prognosis: to deteriorated pieces, as shown in the fig. 2, it is necessary to provide the replacement, because the remaining cross section becomes insufficient to withstand internal forces. For the other pieces in the initial stage of deterioration, when established that the piece of the cross section is sufficient to withstand internal forces, does the treatment as from the removing the decayed wood and cleaning the place and, then, applies the chemical (based on water) through brushing process or product introduction (galleries) with injector nozzle, as prescribed in [21].

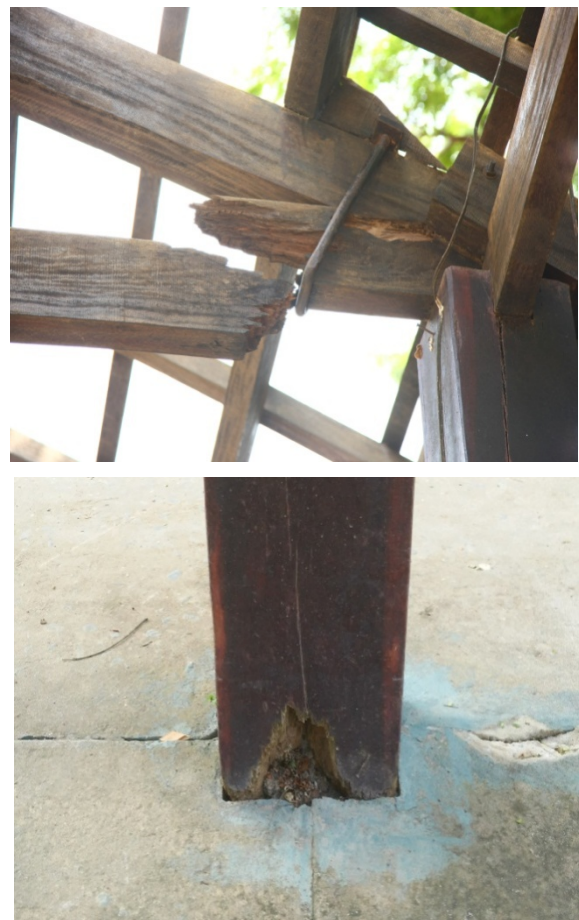
Inspection: deterioration by biotic agents - wood decay organisms (decay fungus) and consequent rupture.

Diagnosis: pieces (girders, lattice bars and pillars) damaged by decay fungi attack, due to the accumulation of moisture and lack of periodic preventive maintenance and, consequently rupture by traction, due to reduction of cross section resistant (Figure 3).

Figure 3. Pieces (girders, lattice bars and pillars) degraded by action of decay fungus

Prognosis: for the damaged piece, as shown in the photo of Fig. 3a (lattice bar), must be provided the replacement in view of rupture thereof. For the other pieces, without continuous contact with moisture and early stage of decay, when established that the cross section of the piece is sufficient to withstand internal forces, it is advisable to cleanliness of the place and then treatment with application of chemical (based on synthetic pyrethroid and carbamate) through brushing process, as prescribed by [21].

For the case presented in Figure. 3 (base of column) can be applied the same procedure, however, initially, it should be removed the soil in contact with the wood base, to be able check the level of deterioration of the element under study, well as, if the remaining cross section can absorb the acting forces. In this case, knowing that such elements (columns) will be exposed to view of local patrons and, for aesthetic reasons, it is recommended to replace them. Reinstalling should be conducted with treated wood [21] and positioned to avoid direct contact with the ground.

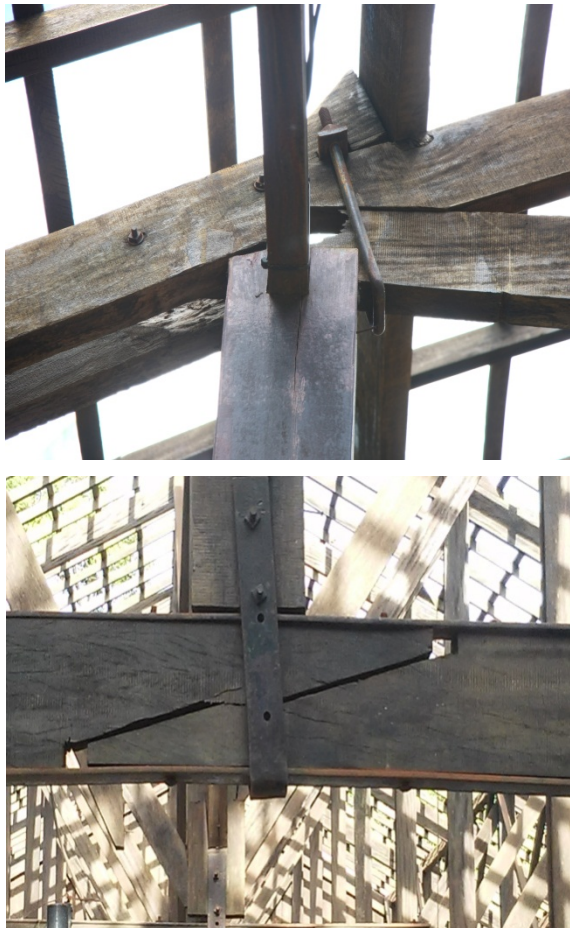
Inspection: rupture of the connections.

Diagnosis: a) according to Figure 4, there was rupture of connection between the bars of the chords (upper/lower) due deterioration caused by attack of decay fungus (moisture accumulation and no periodic preventive maintenance), as well as the lack of dimensioning of the connections [21]; in fig. 4b, there is connection rupture between the bar of the lower chord due to the high shear stress parallel to the fibers acting on the tooth/notch and to the embedding in wood caused by the insufficient number of metal pins.

Figure 4. Connections - regions of support and middle of the span

Prognosis: For the damaged piece, as shown in the photo of Figure. 4 (lattice bar) must be provided the replacement in view of wear thereof. The reconstruction of the connections between the bars of the chords should be performed with the use of wood connecting plates positioned on the lateral faces and with the use of metal pins (screws or nails), properly sized according to requirements of [21] - Item 8. Due to the high relative humidity of room air, it is recommended the use of metal pins with corrosion protection.

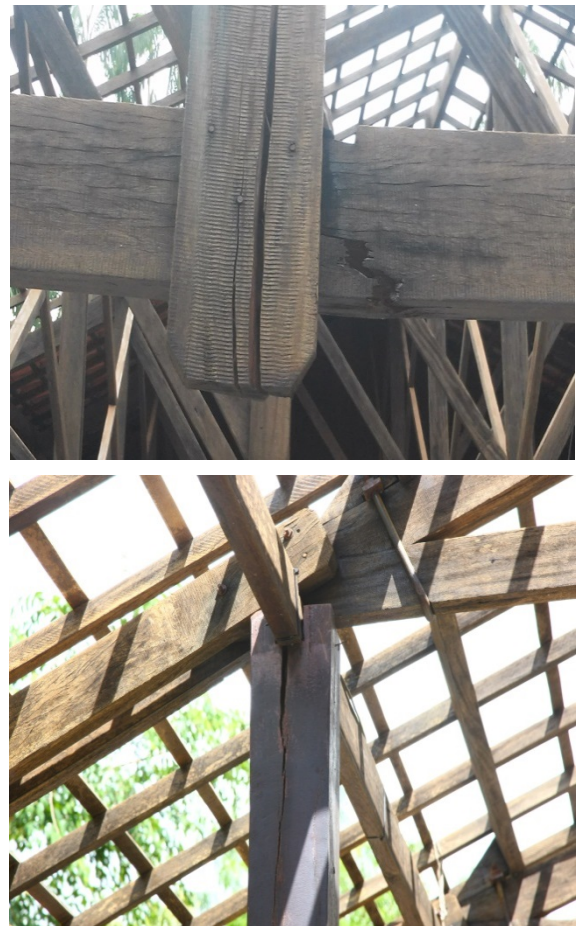
Inspection: rupture of the structural elements.

Diagnosis: a) according to Figure 5, the rupture due traction was verified, the bar of chord (tractioned) because of deterioration by decay fungi attack (moisture accumulation

and lack of periodic preventive maintenance). In the same figure, it was observed cracking of the vertical bar (stud) as a consequence of the rupture of the lower chord bar and excessive vertical deformation of the structure; b) in Figure 5, it was noted in the pillar, a vertical crack (cracking) probably, originated from the implementation of notch and accelerated loss of wood moisture.

Figure 5. Structural elements in ruin (lattice bars and columns)

Prognosis: For pieces in a state of ruin of the lattice bar, must be provided the replacement of it. Regarding the pillar, there is three considerations to be made: *1st) About the preservation:* It is recommended the internal handling of the crack, with initial cleaning by air jet and, then, apply water-repellent products (fungicides and insecticides); *2nd) About the structure:* after checked that the cross section is resistant to the action of acting forces and, with completed the first step, the procedure is reconstitution (crack closure) through the use of through-bolts positioned perpendicular to the crack. By aesthetic reasons, the "head" the bolt and the nut and washers were embedded in the faces of the pillar; *3rd) About aesthetics:* It is recommended the surface treatment, by cleaning and plastic mass of manual application and, thereafter, the surface finish is made (sanding, painting).

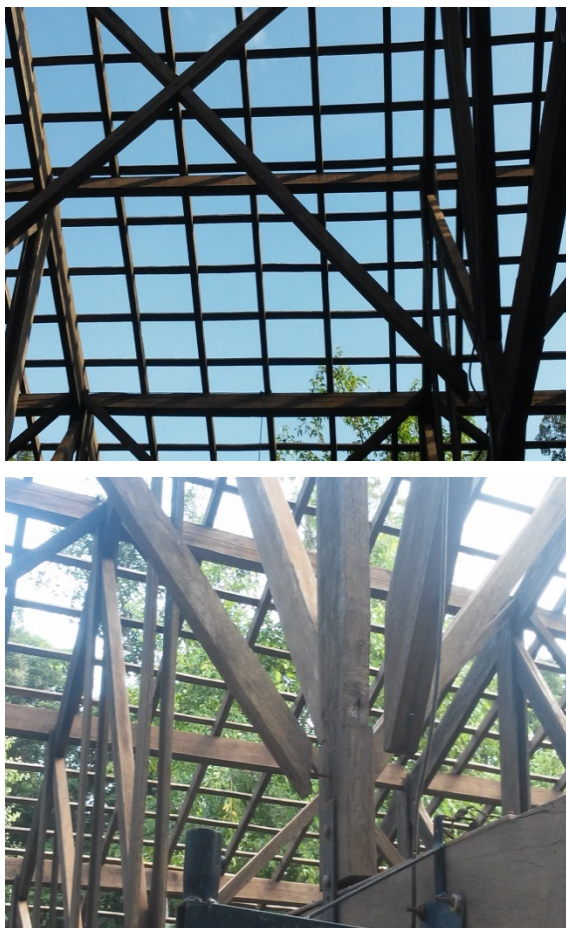
Figure 6. Vertical bracing system

Inspection: Global Instability of lattices.

Diagnosis: It was observed that the connections between the vertical bars of bracing system and the lattices were connected improperly, through metal pins (nails) (Figure 6), causing lateral instability of the lattices. It was also checked that the inclined pieces (tractioned) that comprise the vertical upwind system does not meet the requirements of [21] - Items 10.3, referring to local stability.

Prognosis: To promote lateral stability of lattices, it is

recommended to locking the lattice on the supports, well as the substitution of the current bracing system (in wood), by other, distributed over the roof planes and the inferior chord bars. The foreground is composed of metal lifters (diam. 12.5 mm), forming the setting "X" and joining knots of the upper chords of adjacent lattices, comprised between two lines of consecutive girders. The second, forming a horizontal plane at the level of the lower bars of chords, composed by metal lifters (diam. 12.5 mm) positioned perpendicular to the lattices, joining knots homologous of adjacent lattices. These systems will be arranged at the end of spans of the shed, well as in the intermediate, spaced every two spans. Particularly, in the end of spans, in the horizontal plane, the metal lifters will be replaced by rigid pieces of wood (cross section "T-type", and the "soul" of 5cm × 10cm and "table" × 2.5cm 15cm) and, among them will be installed metallic lifters (diam. 12.5 mm), forming the configuration "X" and joining knots of the lower chords of two adjacent lattices. All metal lifters should be installed with "stretchers".

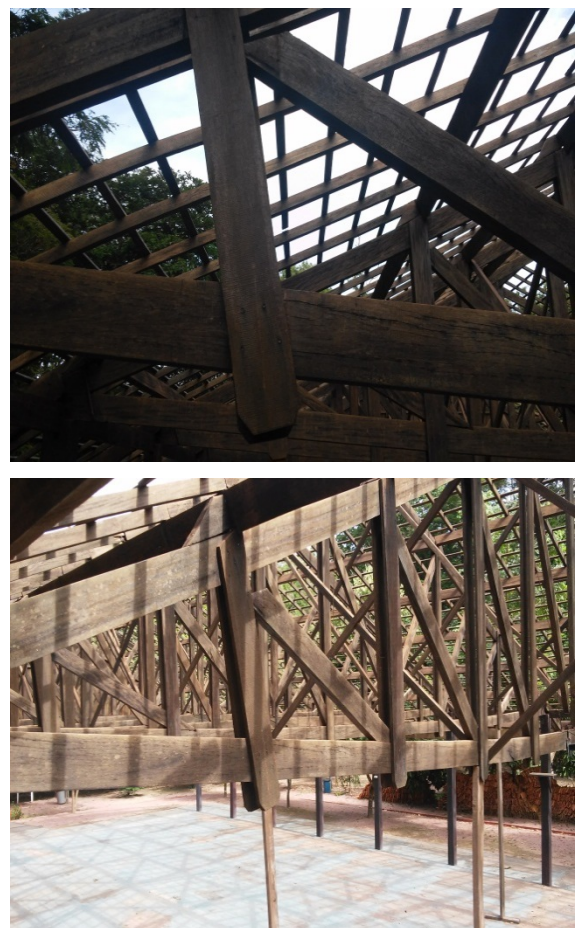
Figure 7. Bracing vertical system

Inspection: excessive deformation of the lattice.

Diagnosis: It was observed that several lattices are with excessive vertical displacement, not answering the requirements of [21] - Item 9, and this fact is the result of several factors such as: low stiffness of the lattice and

structural elements; excessive deformation of the connections of support and of the middle span. Excessive displacement caused the loss of verticality of extreme studs, as well as disconnection of some diagonals (Figure 7).

Prognosis: To reduce the vertical displacement to acceptable levels, according to the normative document cited, two procedures are recommended: 1st) Adjust the connections between the bars of the chords (previously mentioned); 2 st) Increase the cross sections of the bars of the chords (upper and lower) of the lattice; 3) Apply inverted displacement in the central knot of the lattice.
