Historic “HAUFF” Timber Roofs in Poços de Caldas in Brazil

Abstract This research presents the assessment of historic structural systems timber roofs type “Hauff” of constructions existing in Poços de Caldas, Minas Gerais, Brazil. The large timber structures originated with the engineering company “Hauff”, whose production of timber structures contributed in great measure to the technological advance of the industry of construction engineering with wood in Brazil. Based on photographic by techniques of visual inspection (NDT) and descriptive documentation, this paper offers examples of timber roof structures that constitute most of type “Hauff” roof structural systems, such as, lamellar roof structure, sawn lumber nailed arch, plywood arch, shed truss roof, that were built between the years 40 and 60 in the city at Poços de Caldas in Minas Gerais. The timber structures with “Hauff” were built in various regions of Brazil at that time.

Current Assessment of timber roof structures type "Hauff", in Poços de Caldas

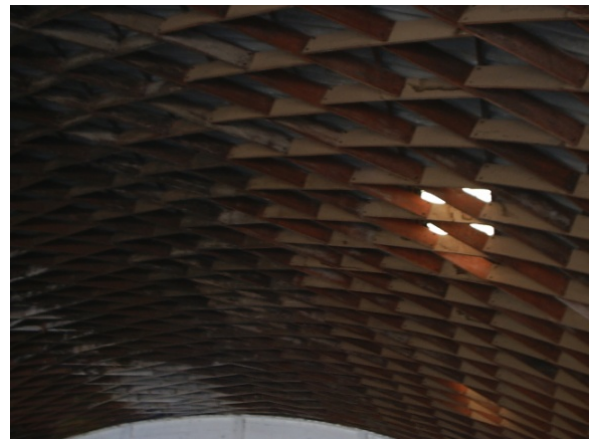
(b)

Details of lamellar roof: moisture migration from tiles.

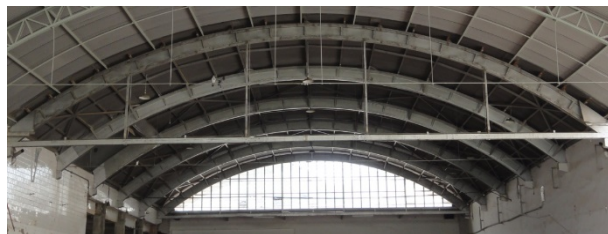
Figure 6. Roof RTH-09: Structural system type plywood arch ~ 22m of span

The roof RTH-09 (Figure 6) has structural system type plywood arch, with approximately 22 meters of span. That is situated on GPS coordinates $21^{\circ} 47' 33,20''S$; $46^{\circ} 33' 48,85''O$; and altitude of 1207 meters. The wooden parts of this structure were with enamel paintings in gray, and the structural elements and metal rods, had good repair. It is probable that the wood is Peroba Rosa, because pink staining of purlins.

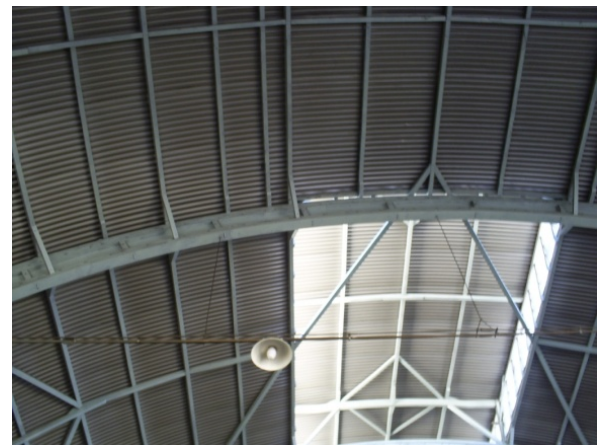
(b)
Plywood arch structural system ~16 m with skylight.

span, and with skylight central projection of natural light (Figure 7b). The wooden parts of the roof RTH-10 were with enamel paintings in gray, and the structural elements and metal rods, presented in excellent condition.
