Rehabilitation of Landslide in the Settlement Mahmutovići, the Municipality of Sapna

Abstract The paper analyzes the causes and mechanisms for sliding in the settlement Mahmutović, municipality of Sapna, that threatened three residential buildings. After the investigations carried out (four exploratory boreholes B-1 to B-4) and detailed engineering-geological mapping, a detailed engineering and geological map of the landslide was prepared. Based on the established properties of the landslide (size, volume, type of landslide), the causes and mechanisms of sliding, it was proposed measures of remediation landslide. After simulations on numerical models, using the PLAXIS 2D v8.5 software package, it is suggested to build a retaining wall on the counterfort, making of drainage systems in the form of fish bones and regulation of the roof water and fecal water in the appropriate receiver or drainage system.

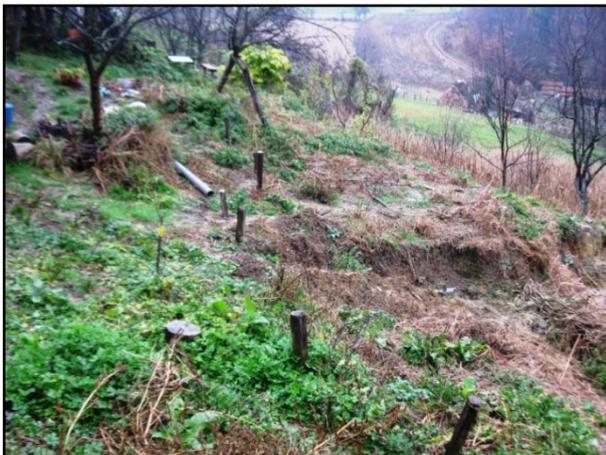
In 2014, during the heavy rains, in the settlement Mahmutovići, the municipality of Sapna, a landslide was activated that threatened three residential buildings. Due to slipping, plastic sewer pipes are broken, while the auxiliary dryer is destroyed and moved 40-50 meters from the original location. As a temporary measure of remediation under the houses, nylon is placed that prevents further soaking and sloughing of the soil. To stabilize the terrain, 20 wooden pilots were inserted into the ground. It has been observed that in one of the three buildings there are no gutters, so all the water flows over the surface of the terrain and contributes to the instability of the terrain.

Figure 2. Wooden piles

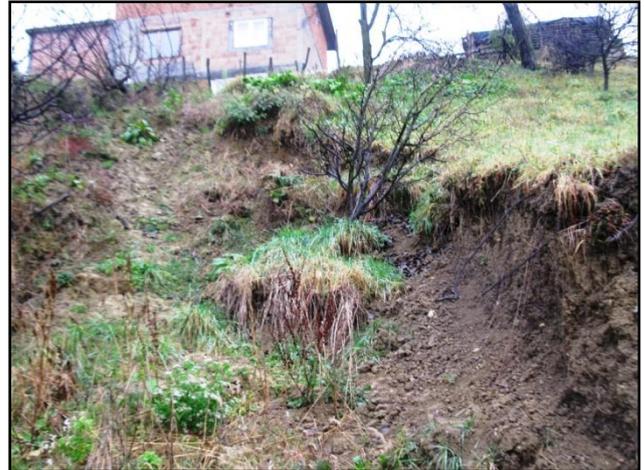
The landslide was created due to the slipping of a surface covering consisting of sandy-dusty and marl clay over the substrate represented by marl and sandstone. It is a shallow landslide, where the depth to the sliding surface is 3.0m.

Figure 3. Sliding body

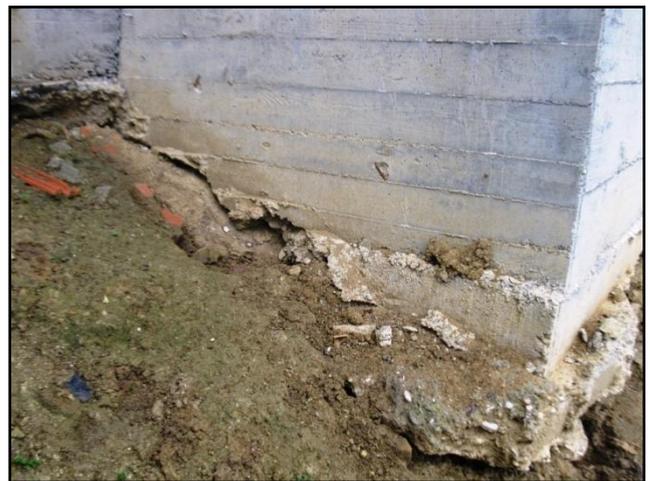
Figure 4. The endangered foundation of the building

The retaining wall on the counterfort will protect the collapse of three residential buildings.

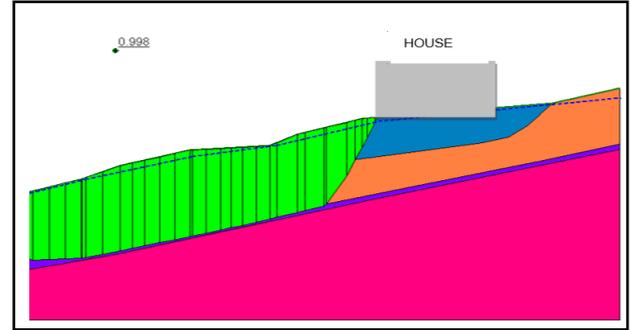
Figure 8. Safety coefficient for sliding surface I-I, $F_s = 0,998$

The calculated safety coefficient for the slope in the natural state is $F_s = 0,998$. This coefficient is unsatisfactory for the stability of the slope. Based on the safety coefficient it can conclude that this is an unstable slope.

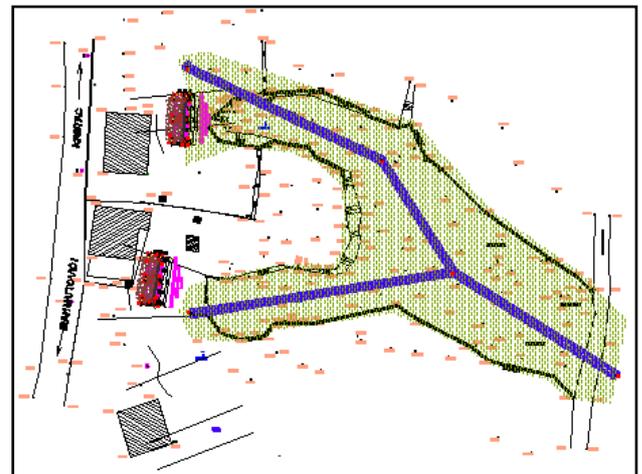
Figure 9. Proposed remediation measures (retaining walls under houses and drainage system in the form of fish bones.)

Based on the determined general properties of landslides such as (size, volume, type of landslide), causes and mechanisms of moving of earth, proposed remediation measures are consisted of: making of retaining structures on the counterforts, a drainage system in the form of fish bones for the collection and drainage of surface and groundwater and regulation of the roof water and fecal water in the appropriate receiver or drainage system.

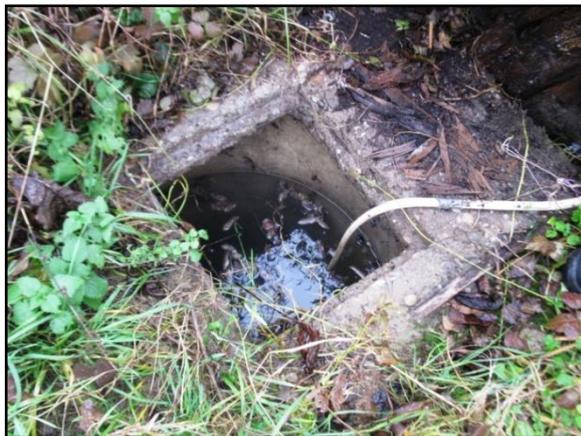
At the indicated location, no surface and groundwater were recorded in the exploratory boreholes. There are two wells in the landslide. In the first well whose depth of 3.0 m is registered water at a depth of 30 cm from the surface of the terrain, while in the second well, the water level was not registered because it was closed. According to the statement of locals, this second well with a depth of more than 6 meters is operational.

Figure 22. The well 1

The appearance of water in the wells indicates that the slope is partially watered and that for these reasons it is necessary to do the drainage system as proposed in the project. The drainage capacity has been estimated based on experience on similar landslides. It is planned to install perforated drainage pipes $\Phi 300\text{mm}$ in the total length of 165,65 meters. The drainage pipes will be placed at a depth of 2-3 meters in the substrate. The goal of the drainage production is controlled acceptance and drainage of water from saturated soil.

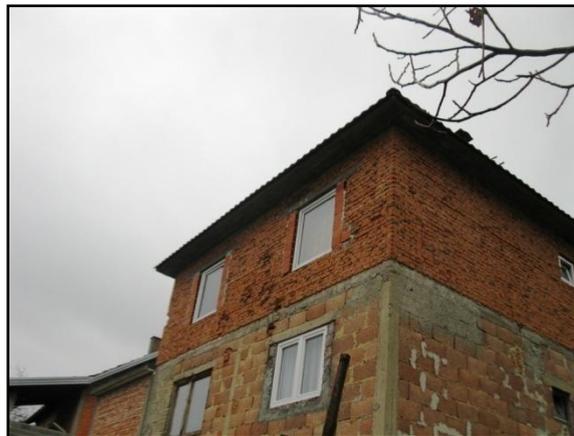
Figure 24. House without gutters

On the field, it has been observed that there are no gutters in some houses, and the water freely scatters over the surface of the terrain and saturates the soil. In this way, the stability of the slope and the stability of the objects on the slope is endangered. To regulate precipitation waters from the roof surfaces, the project of landslide rehabilitation foresees that all roof water from all three facilities will be collected and planned in the appropriate receiver or drainage system.

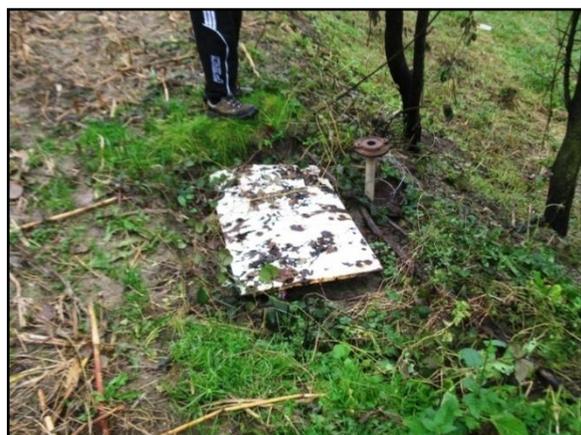
Figure 23. The well-2 (locked)

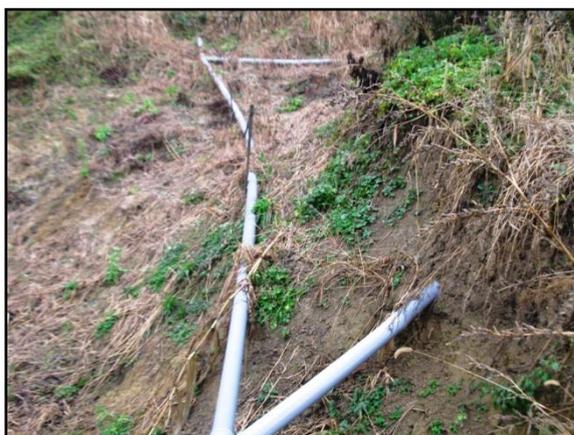
Figure 25. Broken fecal pipes

The project provided a solution to the management of fecal water from all three facilities, bearing in mind that these waters could be freely scattered over the surface of the terrain, which could again destabilize the slope below the facilities.
