# Geological Assessment of Landslide Occurrences in Okemesi Area, Southwestern Nigeria

**Abstract** Landslide occurrence in Okemesi, an ancient town in the southwestern Nigeria on 24<sup>th</sup> of September 2017 was the third in the last two decades that led to loss of properties worth millions of Naira. This paper presents a geological investigation and quantitative modelling of the topographic surface of the area of landslide occurrence with the view of identifying the factors responsible for the land failure mechanism. The investigation included reconnaissance survey, geological mapping of the area to determine the underlying lithologic units, systematic sampling of soils and rocks at the affected sites at a sampling interval of 100 m, determination of geotechnical properties of the soils and rocks as well as Atterberg limits. Index and engineering properties of the soils such as load bearing capacities of the rocks and soils, repose angles and specific gravity were determined in the laboratory. The result of geotechnical analysis revealed that the soils are predominantly sandy clay with clay content ranging from 9.0 - 24.6%, sand content 60.2 – 70.6%, and silt content 13.5-2

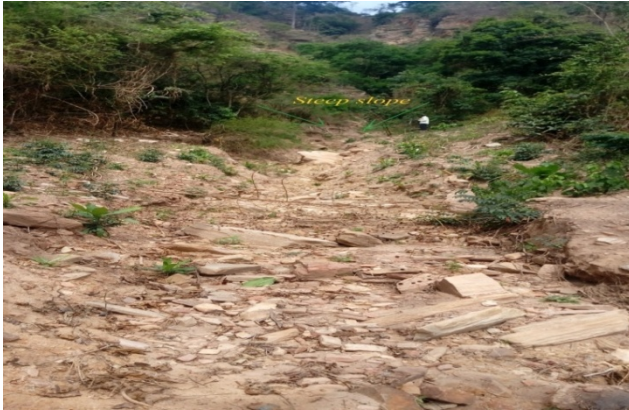
**Figure 5.** Photograph of steep slopes that facilitated the movement of material down slopes

An eye witness account revealed that landslides occurred on the 24th September, 2017 in the morning between the hours of 1:00 am and 6:00 am after a torrential rain that lasted for three consecutive days. The sliding was accompanied by loud explosions and vibration that was felt in the surroundings. According to him, no life was lost but buildings were affected by the large boulders that were

sliding towards the toe of the hill (Figures 5 & 6). The summary of geotechnical results is presented in table 1.

From the geotechnical properties of the soil samples analyzed the soil samples collected showed more susceptibility to landslide or slope failure. Remedial measure for earth slope stabilization includes reducing the height of the slope loading at the toe of the slope, benching, fattening or reducing the slope angle etc. The slopes should be improved on by methods like; drainage control, and slope flattening. The latter reduces the weight of the mass tending to slide, providing a support below the toe and this support also increases the resistance to sliding and hence increases the stability. Also, grouting and injection of cementing materials into weak zones also help in stability. This highlights the need for more rigorous analysis of the soil and subsequent adoption of appropriate prevention techniques. The mitigation method does not help in avoiding the landslide but helps to reduce the loss of life and damage to the property that can be caused due to the landslides.
