Recovering Impact Strength of Fractured Rice Husks Fibre Reinforced Polypropylene Composites Using Healing Agents

Abstract Plant fibre reinforced polymer composites, of which rice husks fibre reinforced polypropylene composite is an example, are gaining prominence in engineering applications. Rice husks fibre reinforced polypropylene composite is ecofriendly, affordable and it is commonly used for light load structural and non structural components as well as structures. When fractured by rapidly or gradually applied loads, the rice husks fibre reinforced polypropylene composite cannot be economically repaired using traditional repair methods such as patch, bolted or scarf repair which would be applicable for leaf based as well as seed hair based fibre reinforced polymer composites. In this research, repair by refilling the damaged volume by injection of healing agents has been investigated. The repair helps in recovering part of initial impact strength lost during destructive testing. The composite test pieces were produced by injection moulding, cooled and tested for impact strengths. Impact strength values for pristine test pieces were a maximum of 61 J/mm². The destroyed test

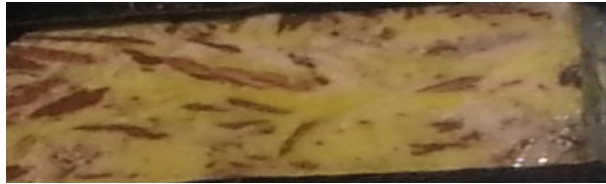
Figure 1. Test pieces with % fibre vol. fractions

Test pieces with 50% fibre vol. fraction

Test pieces with 40% fibre vol. fraction

Test pieces with 30% fibre vol. fraction

A mixture of dried rice husks and clean and dry shredded polypropylene were loaded to the heating chamber through a hopper. Teflon was applied at the inner walls of the mould. Temperatures were set to 210°C at the equipment control panel [13]. The heated mixture was moulded at a pressure of 12 MPa after preheating for 10 minutes. The mould was then separated to allow access to the manufactured test pieces which were 10 × 10 × 75 mm in dimensions. The test pieces were left to cool at 24°C (ambient temperature). For each combination (by volume fractions), five test pieces were produced for purposes of replication and hence a total of 20 test pieces were initially produced. Charpy impact tests were then carried out as per ASTM D 6110 –10, [14]. The results were as shown in Table 1. Fig. 1 shows test pieces with various % fibre volume fraction.

Test pieces with 20% fibre volume fraction had similar morphology with those with 30 % fibre volume fraction.

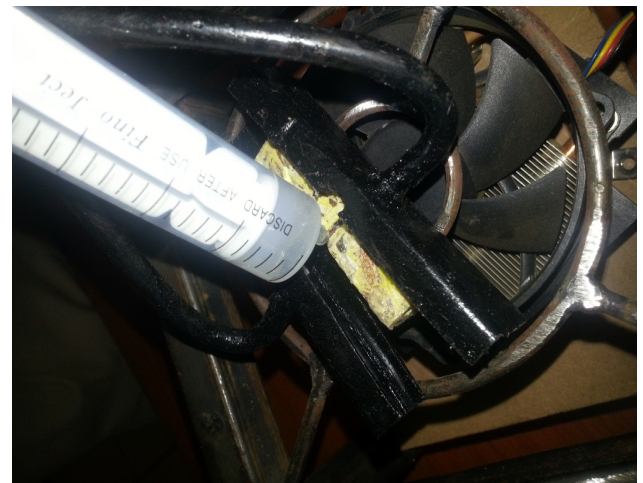
Figure 3. Healing set up when using draught fan

Also a small fan rotating at 800 revolutions per minute was powered and fitted on the opposite side to the direction of flow of the healing agent to aid in the speedy infiltration of the healing agent so as to completely fill the damaged

volume. Forty five test pieces were healed in this manner before retest destructively. The healing set up was as shown in fig. 3. The recovered impact strength test result recorded in each case was a mean for five test pieces and for all the 45 test pieces, the results were as recorded in Table 4.

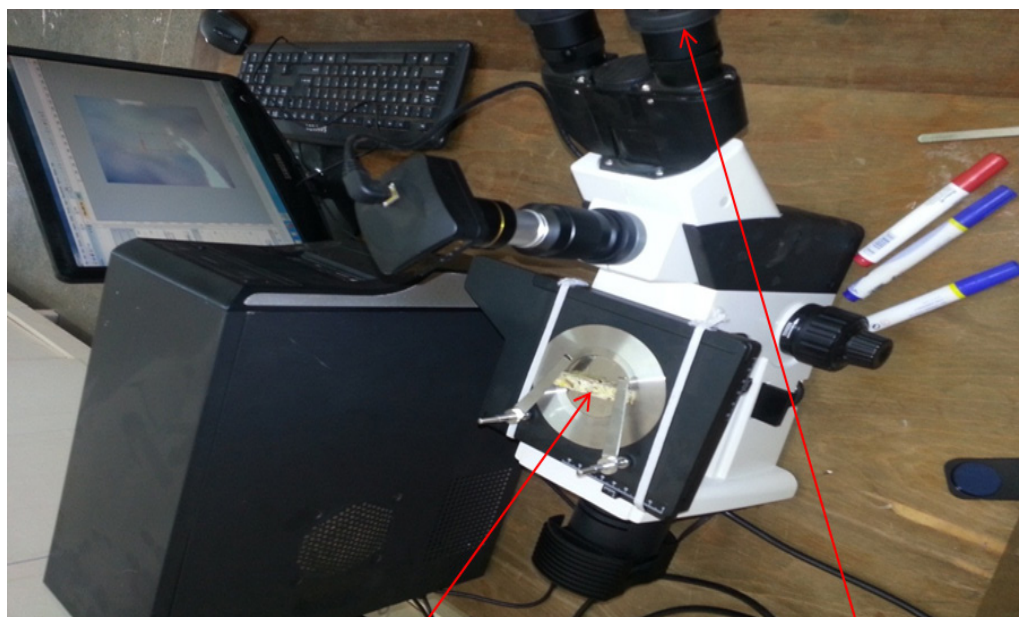
Figure 4. AmScope set up for morphological investigation

Fractured coupon whose morphology is being studied

Eye viewing point

Every fractured test piece was observed under an AmScope microscope (ME 1200 B/T series) using 40 \times magnification as well as fine focusing sensitivity of 0.002 mm. The fractured surface was analysed for matrix cracking type of failure, appearance of interface and presence of voids caused by fibre pull out. The set up was as shown in fig. 4. The morphology of the fractured surface is discussed in section 3.1.8.

and the visual display unit were as shown in fig. 4, from the observation, it was apparent that failure was mainly by fibre pull out and matrix cracking. Fibre pull out was exhibited by presence of voids left behind by fibres that had disengaged from the matrix. Matrix cracking also occurred as evidenced by continuous matrix surfaces and the roughness of the surfaces indicated that the failure occurred at relatively high impact strengths. The morphology details are shown in fig. 9.
