Water Quality Monitoring and Assessment of a Small SWM's Produced Leachates

Abstract The water quality of surface and groundwater aquifers in the vicinity of a small solid waste management (SWM) is being investigated in this paper, with respect to the leachates' treatment. The operation of a ten year old waste management establishment in an agricultural area of northern Greece serves as our case study. We are investigating, after an accident of overflow of the produced leachates, the treatment plant and its efficiency. Water samples from the immediate vicinity of the facility have been collected and analyzed in the laboratory of Environmental Engineering and Planning, at the department of Civil Engineering of the Aristotle University of Thessaloniki. The laboratory results were compared with the environmental limits for water use in irrigation (higher than those for drinking water). The analyses indicated that the samplings from the facility's outflow and the nearest to the landfill water aquifer were found polluted, even several months after the overflow. Since the water sample taken from the landfill's outflow exceeded the environmental limits, the contamination is directly conn

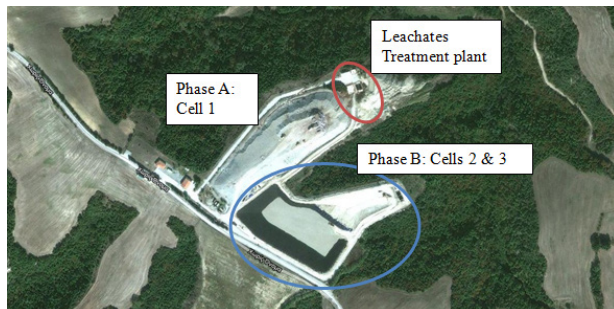
Figure 1. Google map of the sanitary landfill of Katerini (2012)

(Figure 1), this route for the leachates is considered the most efficient. In any other way, if, for example, the leachates from storage tank 2 were driven directly to reverse osmosis, a third storage tank should be constructed, in order to counterpoise the two different flows of the leachates.

It came to our attention that, after the intensive rainfall of October 2010, a large amount of unprocessed leachates was driven to Bufolakas stream, putting the surrounding aquifers in great environmental risk. As google map in Figure 1 shows, there are pristine conditions in the area, which

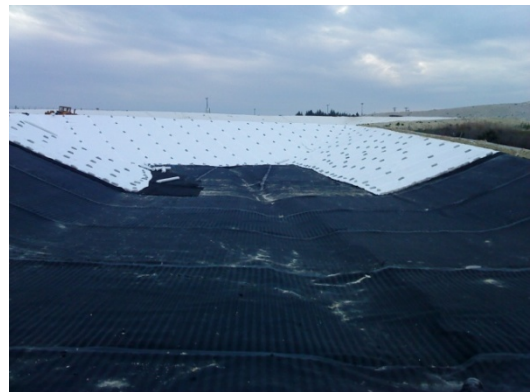
The waste management facility consists of three cells where the wastes are disposed and a plant of processing the leachates ([8],[9]). The bottom of the cells is covered with an impermeable layer which consists of a combination of a natural (50cm of clay) and artificial (2.5cm of synthetic membrane) sealing, as shown in Figure 2. In that way, the flow of the produced leachates to the ground is not permitted, protecting groundwater from pollution. The cells are designed with such slopes so as to facilitate the collection of the leachates and to avoid the accumulation of large liquid quantities within them. The leachates are collected through pipes at the bottom of the cells (Figure 3) and directed to the treatment plant. After the completion of the filling of each cell a final layer of clay, of soil protection and of plant soil must be laid, in order to avoid the penetration of surface water in the cell and assist the environmental and aesthetical restoration of the landfill[6],[10].

Figure 2. Construction works of the 2nd phase at the landfill of Katerini. Artificial sealing in the 2nd cell of the landfill. (ADT-Omega ATC, 2008)

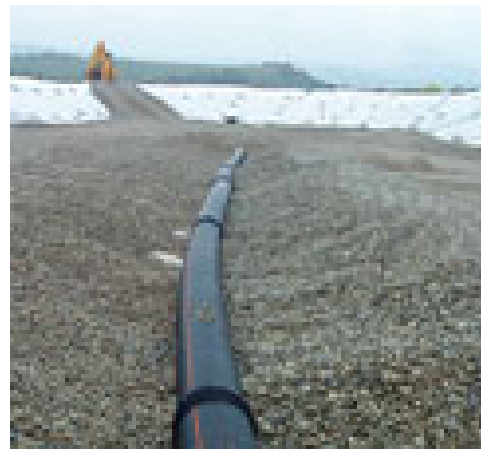
Figure 3. Construction works of the 2nd phase at the landfill of Katerini. Leachates collection pipe. (ADT-Omega ATC, 2008)

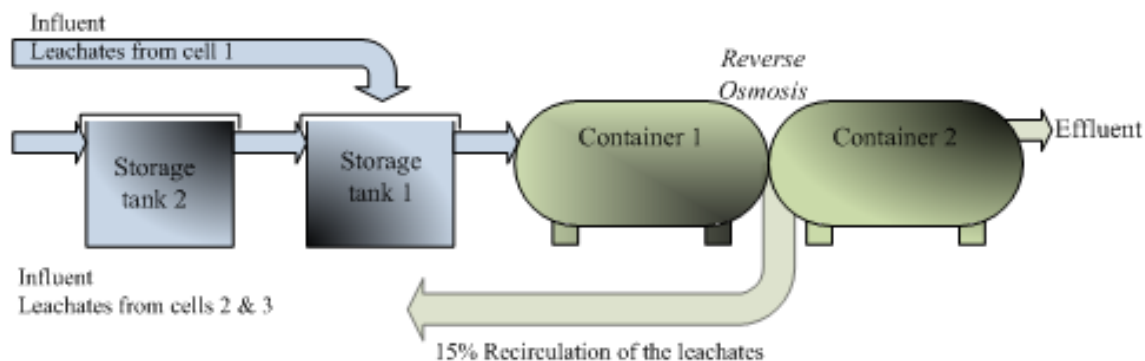
Figure 4. Leachates' flow chart of the landfill of Katerini

The solid waste management of Katerini operates as follows. Leachates from cell 1 are directed to storage tank 1 and then to RO plant (Figure 4), which consists of two containers. The leachates are entering the first container (Figure 5), where the cleaning membranes and sulfuric acid are, and pre-filtering takes place. In the second container (Figure 6) there is a two-stage membranes system with high pressure and recirculation pumps.

The leachates from cells 2 and 3 are driven first to storage tank 2 (Figure 4) and then are transferred, through storage tank 1, to the RO plant. Given the design of the landfill

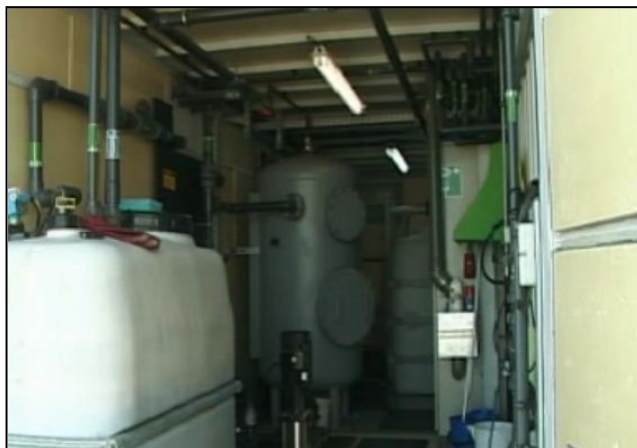
Figure 5. Container 1. Pre-filtering of the leachates

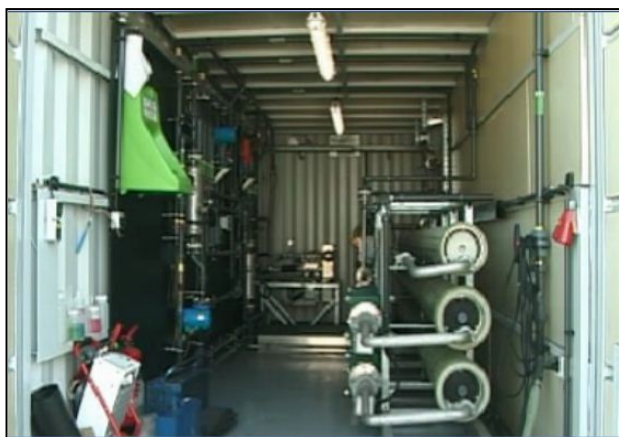
Figure 6. Container 2. Treatment of the leachates

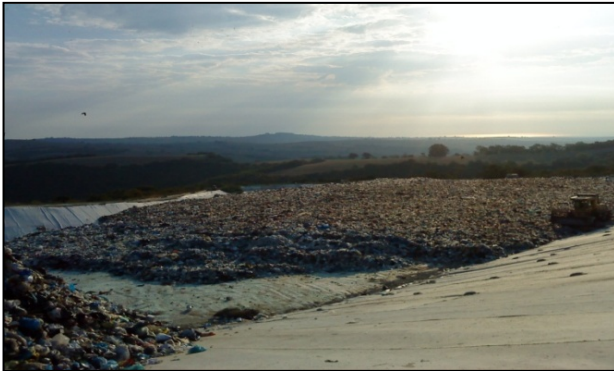
Figure 7. The 2nd cell of the landfill of Katerini in operation

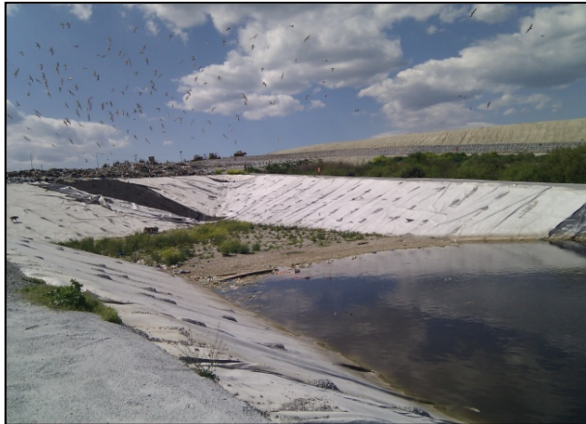
The first cell of the landfill of Katerini was designed to operate for 7.5 years and finally operated for 10 years, resulting in overfilling of the cell and in the belated start of its covering with impermeable surface. During the period of February to March of 2010, as the construction of the second phase of the landfill was still in progress, storage tank 2 was full of the leachates coming from cell 2, which was already put in operation (Figure 7). Due to extensive rainfall, storage tank 2 overloaded with rainwater too. Due to the fact that the RO plant was in recess at that period of time, the leachates were directed through underground pipes from storage tank 2 to cell 3 (Figure 8). As a result the leachates remained unprocessed and both cell 3 and storage tank 2 were filled. Shortly after, while the first cell was still uncovered, another intense rainfall in October 2010, overloaded the storage tanks, and unprocessed leachates escaped into the neighbouring land.

Figure 8. Leachates and rainwater in the 3rd cell

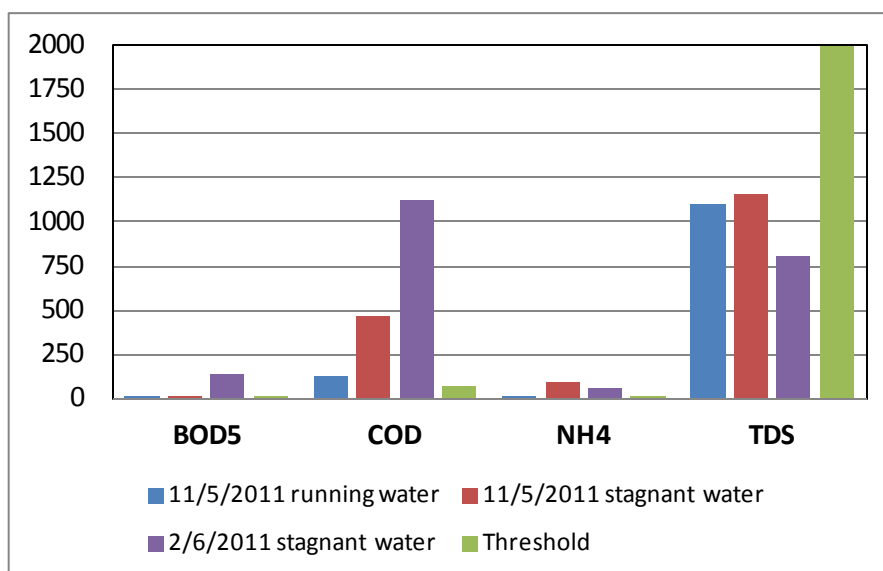
The comparison between the results of the tests and the environmental limits indicated that contamination exists in the closest to the landfill sites (at the exit, up to 200 m downstream; from stagnant and running water), as expected. The laboratory results demonstrate alarming values in BOD_5 , NH_4^+ and especially COD downstream of the facility, as shown in Figure 8, when compared with the concentration limits for irrigational use. The last analysis of stagnant water downstream from the facility (June 2nd 2011) reinforced the evidence of contamination. The results of the lab analyses differentiate in terms of the total dissolved solids (TDS), which seem decreased in the latest sample of June 2011 (Figure 9), but in all cases fall within the middle threshold range of 450-2000 mg/l, which corresponds to the medium degree of irrigation restrictions, according to the Joint Ministerial Decision 145116/02-02-2011, Government Gazette B' 354/8-3-2011[18].

**Figure 9.** Surface water measurements 200m downstream of the facility**Table 3.** Laboratory results of the physicochemical properties (March 2012)

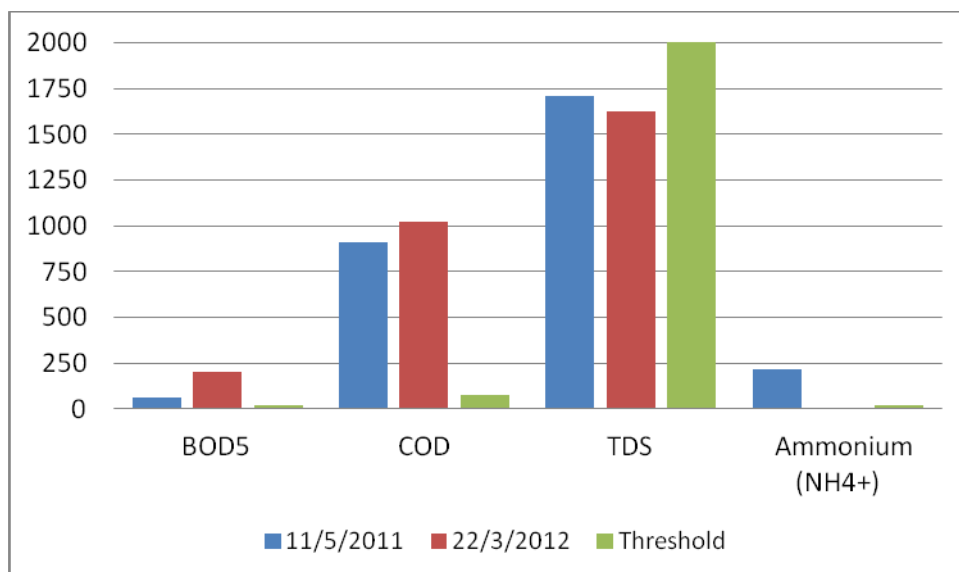
Figure 10. Lab analyses at the outflow of the solid waste facility

More analytically, the physicochemical laboratory results (Table 3) show that the threshold limits are exceeded for BOD₅ and COD at the landfill's outflow, when compared with Table 2. There is an observed increase in these two parameters from the results of May-June 2011 (Table 1), which indicates that the leachates flowing out from the landfill remain untreated. The ammonium ions remained below the limits in these measurements, even at the exit. This comparison is better described in Figure 10, where the concentration limits for irrigational use are exceeded in most cases, and the total dissolved solids are approaching the major degree of irrigation restrictions, according to the Joint Ministerial Decision 145116/02-02-2011, Government Gazette B'354/8-3-2011[17].

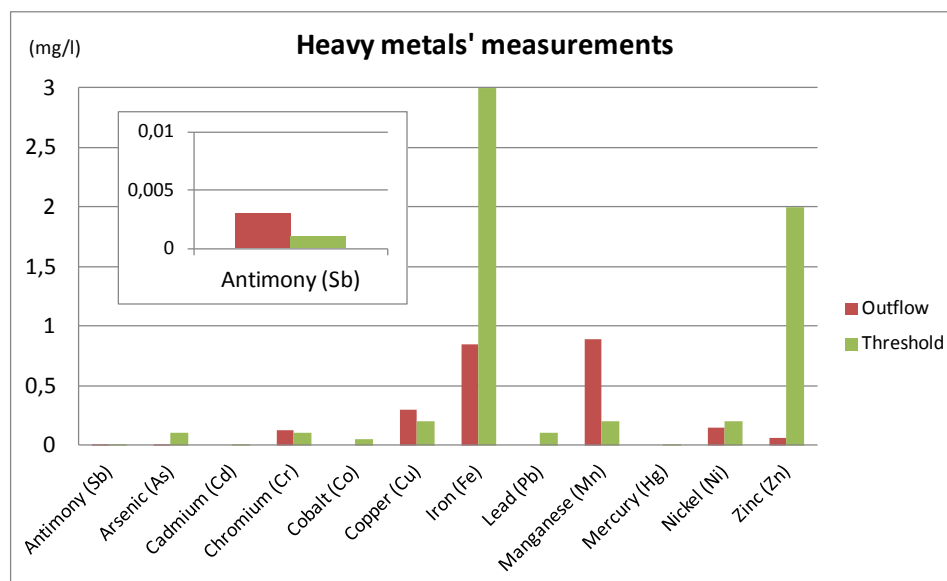
Figure 11. Lab analyses of heavy metals at the outflow of the solid waste facility

On the other hand, the analysis of heavy metals from the same samples show that the environmental limits, set by Pieria's Prefectural Decision 5662[17] and the Joint Ministerial Decision of 2011[18], are not exceeded, as shown in

Table 4 and Figure 11, with the only exceptions of Mn, and slightly Cr and Cu. Analyses on the heavy metals, performed in a private laboratory on behalf of the solid waste management of Katerini in September of 2010 (before the accident), before and after the reverse osmosis treatment (inflow – outflow), are also shown in Table 4. No alarming values were detected then for the heavy metals at the exit of the landfill. It is worth mentioning the treatment is quite effective with respect to the heavy metals, especially in terms of iron and zinc, but not for manganese. Literature focuses on the reduction of heavy metals in the produced leachates[19].
