Hot-Mix Asphalt Pavement Construction Practices in Ghana and Their Impact on Pavement Quality

Abstract Premature asphalt concrete pavement failures are prevalent in Ghana with the major blame often erroneously placed on axle loads. In this study, hot-mix asphalt pavement construction practices in Ghana were investigated. The aim was to establish the potential impact of the practices on pavement quality, performance, and durability. Data and information on asphalt pavement construction practices were collected through a questionnaire survey and supplemented with observation of practices at a number of sites where asphalt paving works were on-going. In addition, condition survey of selected asphalt pavements was carried out. The results indicated that hot-mix asphalt pavement construction practices in the country do not exemplify contemporary advancements within the asphalt paving industry and are partly to blame for the premature failures of asphalt concrete pavements. Sub-standard construction practices are prevalent due, in part, to the existence of significant gaps in the technical specifications used in the country for asphalt pavement construction and, in part, to lack of comm

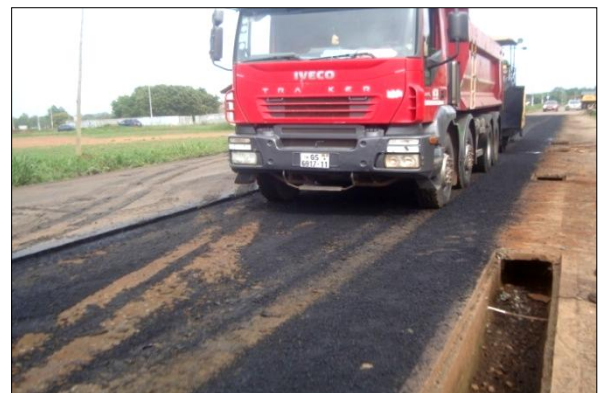
Invariably, application of tack coat is done on the day of paving, ostensibly to prevent accumulation of dirt, but construction truck tyres tended to pick up binder from the surface (Fig. 1). As observed, no preventive action was taken to deal with removal of tack coat by truck tyres. At locations where tack coat is non-uniformly applied or removed by the tyres of construction trucks, slippage failures and de-bonding may occur [23]. The survey established that it is not a general practice in the country to apply tack coat between asphalt layers placed on the same day; 85% of the engineers/technicians and 70% of the contractors confirmed this. In the literature, opinions differ on the necessity to apply tack coat between asphalt pavement layers placed on the same day. Hachiya and Sato [18] have indicated that tack coat between HMA layers placed on the same day is needless provided the underlying course is hot.

Figure 1. Binder pick-up by construction truck tyres

Slippage cracking is caused principally by poor mix quality, poor tack-coating, and binder pick-up by construction traffic. As was noted during the field visits, a major problem identified with tack-coating was binder pick-up by construction traffic when tack-coating was carried out on the day of paving.

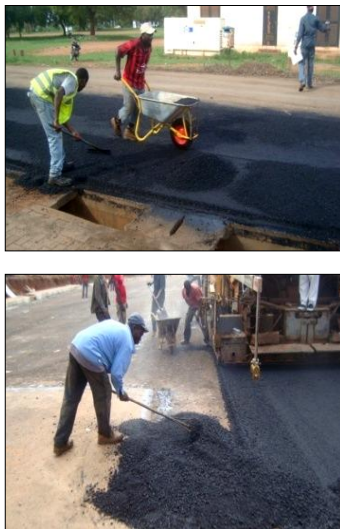
When there is a continuous supply of paving mix, material transfer vehicles (MTVs) serve as surge bins to ensure uninterrupted laydown operation, which is important for reducing non-uniformity of HMA and also obtaining a smooth-riding pavement. Also, MTVs solve the problem of trucks bumping the paver and causing depressions on the pavement mat. Surprisingly, 93% of the respondents indicated that MTVs are never utilized on their projects. The method for establishing the truck–paver contact was the same on all the projects visited: trucks reversed and bumped the paver. Preferably, the paver should move forward into a stationary truck. Manual placement of HMA as observed on site (Fig. 2) did not conform to best practice.

Figure 2. Improper manual placement of HMA

Preferably, HMA must be placed in a pile away from the placement area, carefully deposited with shovels and then spread with lutes. The hand-worked surface is then checked with a straight-edge before rolling starts.

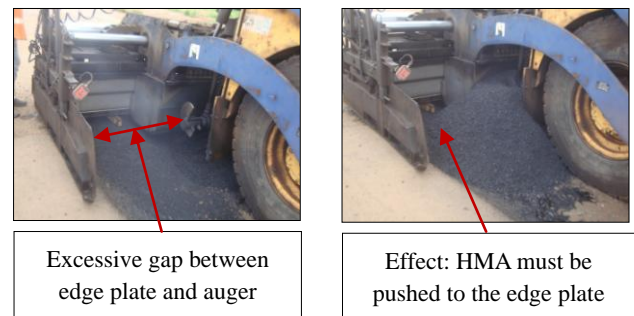
According to Buncher and Rosenberger [24], both the Asphalt Institute and the United States Federal Highway Administration recommend that augers should extend within 300mm to 450mm of the edge gate. Terminating the augers at the specified distance ensures a continuous supply of paving mix to the longitudinal joint to ensure high densities. During the field visits, paver augers were found to terminate between 300mm and 800mm from the edge plates of the paver; a violation of specification requirement to terminate them not more than 200mm from the edge plates (see Fig. 3).

Figure 3. Wide gap between edge plate and auger (left) and its effect (right)

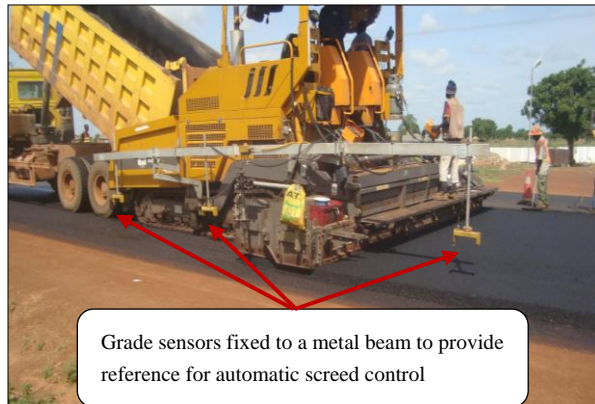
In terms of the grade reference system used in screed control to achieve a smooth mat during laydown operations, 55% of engineer/technicians and 42% of contractors mentioned the erected stringline while 35% engineer/technicians and 50% of contractors mentioned the road surface as the most often-used reference systems; only 10% of engineers/technicians and 8% of contractors mentioned the use of ski. It may be inferred that the use of ski is unpopular. According to the Asphalt Institute [16], erected stringline provides for the placement of the smoothest possible mat. In spite of the responses above, the stringline method was not seen being used in any of the paving projects shadowed. Instead, a mechanism in which grade sensors were fixed to a beam and secured to the paver to provide reference from the roadway for automatic screed control was widely adopted (see Fig. 4). The stringline method was not being practiced probably because of the difficulty associated with their erection and the ease with which the setup is easily disturbed by site activities.

Figure 4. Use of grade sensors to provide reference for screed control

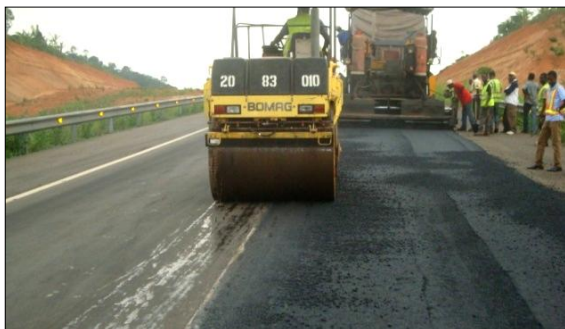
The survey results and site observations established that the straight butt joint is the longitudinal joint technique utilised in Ghana. Although this technique lends itself to easy construction, studies [25, 26] show that it does not provide satisfactory performance compared with the notched-wedge tapered joint. In terms of joint compaction, 77% of the contractors indicated that the technique commonly adopted is to begin rolling from the cold side (see Fig. 5). With this method, the first roller pass occurs in a static mode with a major part of its wheels on the cold lane and only about 150mm overlapped onto the hot lane.

Figure 5. Compaction of longitudinal joint from cold side

All the projects visited practiced rolling from the cold side but studies show that rolling from the cold side produces the worst results whereas rolling from the hot side about 150mm away from the longitudinal joint provides the best joint densities [27]. In constructing longitudinal joints, the less-compacted edge of the cold mat is trimmed before paving the adjoining lane. The extent of cut is not specified, but the survey revealed that, typically, between 50mm to 150mm of the cold lane edge is cut. The Transportation Research Laboratory [28] suggests trimming off the unconfined edge a distance equal to the lift thickness.

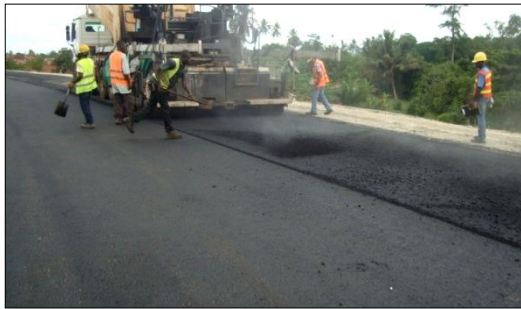
Half of the respondents said that mix segregation is prevalent, the major causes being attributed to paver and asphalt plant operations. As a remedy, 82% said fresh mix is broadcast on the defective area, followed by raking to allow fines to fill the pores (see Fig. 6). Broadcasting as a remedy is only cosmetic as the lower depth of the mat would still remain segregated. Stroup-Gardiner and Brown

Figure 6. Correcting segregation by broadcasting HMA on defective areas

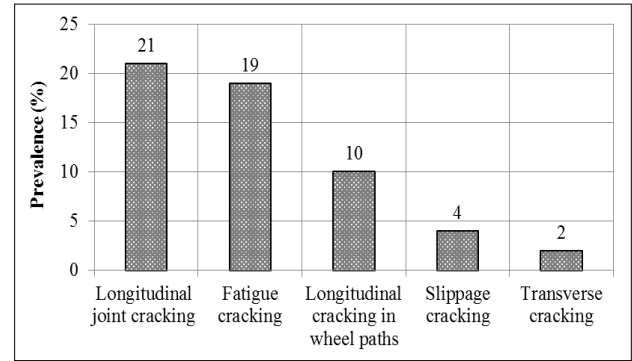
The prevalence of the major pavement distresses identified in the condition survey is shown in Figures 7, 8 and 9.

Figure 7. Prevalence of cracking distresses

The prevalence rate of structural distresses was 56% compared to 38% for functional distresses (Figures 7-9). This implies that distresses that influence the ability of the pavements to carry traffic loads were present on more than half of the study sections whereas those that impact on ride quality and safety, which are the major preoccupation of road users, were identified only on a little over one-third of the study sections.

Cracking distresses recorded the highest frequency of occurrence (56%). Longitudinal joint cracking was the most dominant in this group and, in fact, on the entire sections surveyed. This distress is mainly caused by poor construction [31]. Longitudinal joint cracks, as well as other cracks, allow ingress of water to weaken the bond between the surface lift and the course underneath, leading to de-bonding. Distresses such as potholes, raveling and fatigue cracks were found in the vicinity of longitudinal joints.

Fatigue cracking was the second dominant defect (Fig. 7). Fatigue cracks are usually not expected until after several cycles of repeated loading [30] well into the life of the pavement. It, therefore, appears that the roads which were experiencing fatigue cracking had done so quite early – the average age of these roads being six years. The defect is caused primarily by factors such as inadequate layer thicknesses, saturation of base course, inadequate compaction, and de-bonding.

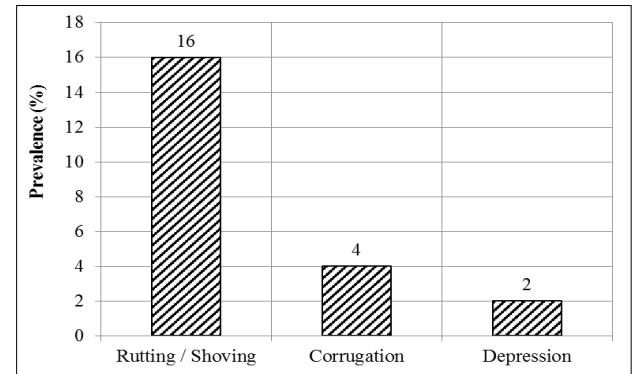
Figure 8. Prevalence of distortion distresses

These distresses, which are normally caused by construction-related factors, were the second most prevalent distresses (Figure 8). Rutting was the most dominant defect in this group and the third in the entire study. It was noted that rutting occurred mostly at sections which experience high stresses from the braking and accelerating actions of slow-moving heavy vehicles such as on urban road sections and at speed hump and toll booth locations.

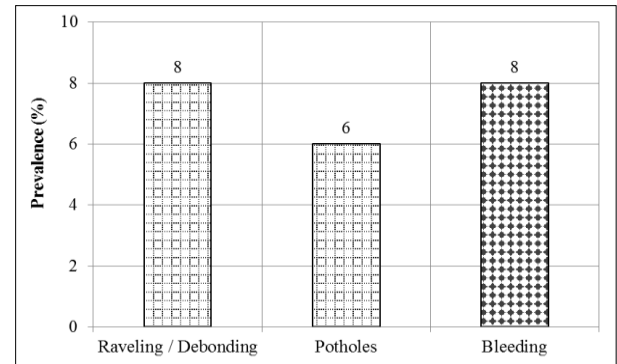
Figure 9. Prevalence of disintegration and skid hazard distresses

Raveling, de-bonding and potholes were the dominant distresses identified in this group, and together had a prevalence rate of 14% (Fig. 9). The causes of these distresses are mostly construction-related and, thus can be mitigated through good construction practices. It was observed that majority of potholes and other deteriorations were uniquely located at or close to the pavement centreline. It is strongly suspected that low longitudinal joint densities and ingress of water through the joint cracks were major contributory factors.
