Cracks Studies Case of Buildings in Sinop City - Brazil

Abstract The building structures are objects of interest in Civil Engineering, appropriate to its importance in sustaining and preserving the building. The monitoring of their behavior can occur for analyzes on structural elements, directly, or other structures for monitoring the building. Such situations encourage the improvement of new techniques for structural evaluations through measurement service elements and interpretation of monitoring data. Amid this context, the present study aims to analyze, diagnose, classify, expose the possible causes and possible solutions of the problems of the buildings studied pathological located at Sinop – MT, where the study included various types of buildings from earthen, 3, 11 e 19 pavements, as residential construction, public and private educational institutions, or for use in the construction step, all intuited with the larger scope of diseases in the municipality, identifying whether or not problems that could compromise the safety criteria, resistance and good performance of buildings.

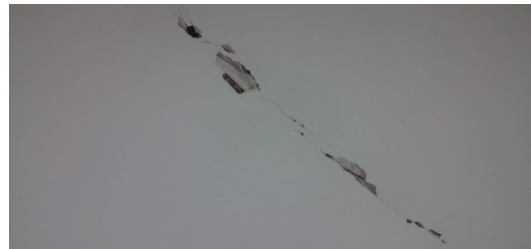
Figure 1. Building A

The first data to be discussed is Building A (Figure 1). This building is characterized by a diagonal cracking already with the coating puffing, having as possible causes may be the foundation elements deformation. This pathology type was very much found in study object, because the building is composed of sets of rooms without links between them, in which some of them were constructed simultaneously, giving indications that the mistakes were spreading equally.

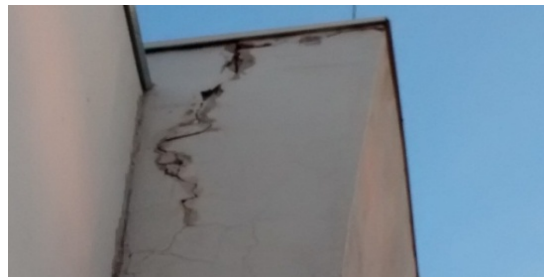
Figure 2. Building A

Figure 2 below demonstrates a volume associated with one of building sets, and can observe humidity problems. The diagnosis process evidence the structural movement of upper and lower beam, however the flat masonry did not follow the movement, causing opening. Consequently, the aggressive agents of medium begin to deteriorate the structure, causing oxidation in reinforcement and may cause structural properties loss.

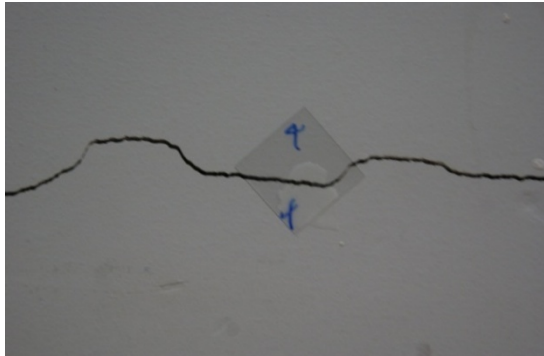
Figure 3. Building B

Building B can be analyzed by Figure 3. The pathology has its direction predominantly horizontal and from one end to the other of the wall. Its probable cause is the first slab backing beam deformation, which resulted in pathology in the connection between masonry and the structural element. The pathology was monitored with fixation of a glass slide, in which it did not collapse, concluding that the crack is passive. However, it is primary importance not only monitoring the local where cracking has already occurred, but of all the buildings, remembering that the preventive maintenance is much more effective than corrective one.

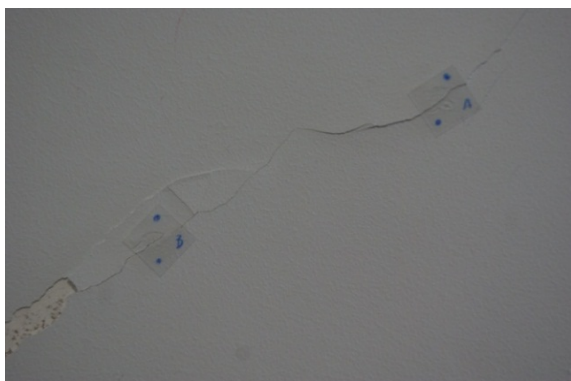
Figure 4. Building B

Figure 4 just below, also the same building on its second floor, has a 1.5 by 10.5 meters balance. It is probable that for joint reasons such as structure deformation of balance and element load concentrated, may have caused a foundation settlement beyond predicted, characterized by fissure with predominant diagonal direction, having as origin the joining of elements beam-pillar and being passive. Preventive monitoring is advisable, as stated above, and it is advisable to insert pillars in balance region, increasing the bearing capacity and, thus, better displacements restricting.

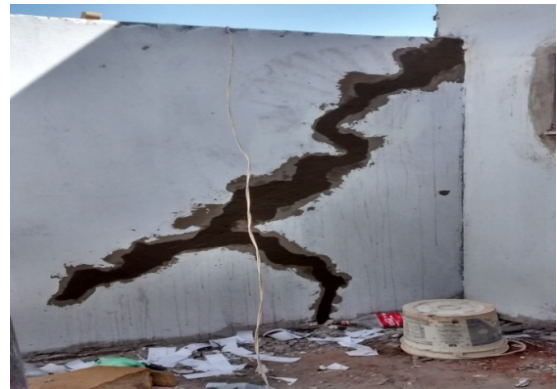
Figure 5. Building C

Building C, represented by Figure 5, shows the pathological style often found in the building, in which the crack was present on both wall sides. Due to the external face is exposed to high solar incidence, it contributes to retraction cracks proliferation, besides the expansion joints absence, inducing active loads in masonry to create its own transmission path. Also present in diagnostic process was the pathological incidences detection of foundation settlement,

due to design phase inconsistency in which it was designed with use of shallow foundation and the grade beam nonexistence, but a block of cast structural masonry concreted with incoherent reinforcement, not being sufficient for requested forces, causing excessive deformations in its elements.

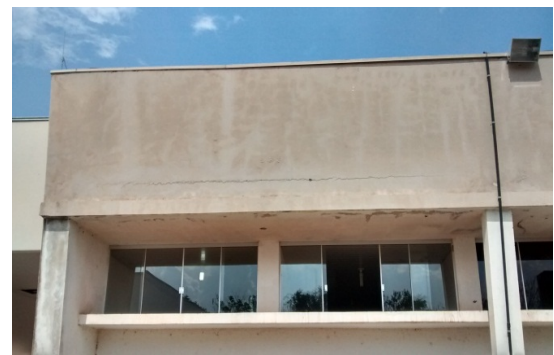
Figure 6. Edification D

Construction D (Figure 6) gives indications of structural element movement, causing openness between structure and gasket masonry, its causes being more likely the slab retraction and support beam deformation.

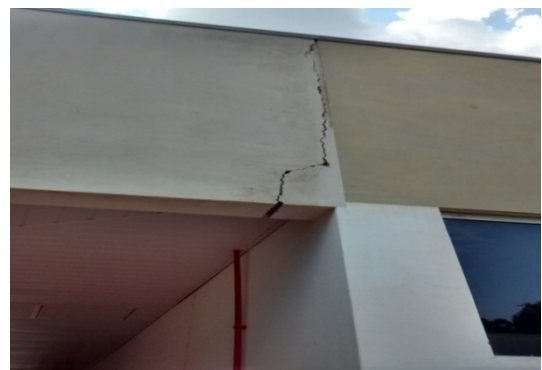
Figure 7. Edification D

Figure 7 and 8, from the 'D' and 'E' buildings, identify vertical predominant fissures. The most plausible hypothesis is that correct reinforcement was not used (shear forces), so that its structural capacity was guaranteed, causing pathology.

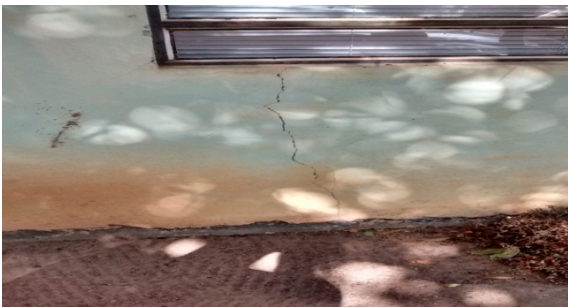
Figure 9. Edification E

Building E (Figure 9) can be proven the counter lintel non-existent. The masonry sealing was not sufficient to ensure the requested stresses, causing cracking. The fact can be verified in several places of building, and it is necessary punctual reinforce.

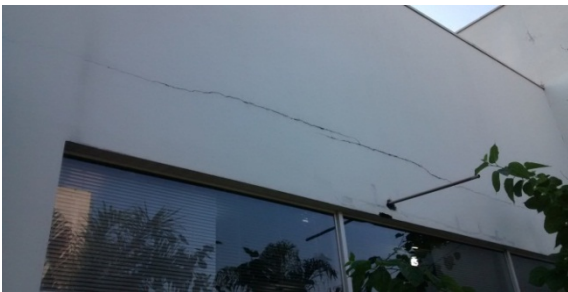
Figure 10. Edification E

Figure 10 of the same construction of figure above, can be proven a horizontal pathology, whose most probable origin is slab retraction or structural element deformation. The same could have happened for several reasons, among them the overload on backing beam or even the low resistance of present concrete. This pathology is located in a set of same institution, composed of laboratories set recently built, since even though it does not have a long time of use; it already presents pathologies equivalent or superior to oldest building set.

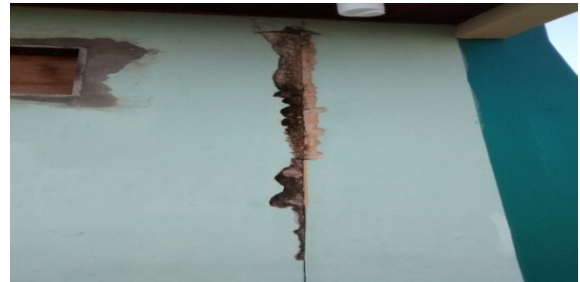
Figure 11. Edification E

By Figure 11 other factors and building properties, as well as the bearing capacity of some structural elements, can be analyzed and discussed. Given the building age, some cracks and pathologies that have not been corrected on preventive maintenance will have to be carried out in a corrective way, as the maintenance lack causes the aggressive means to advance, which appropriate the satisfactory environment that

the opening is found, causing moisture problems, oxidation, retraction and coatings expansion, in which the whole structure is damaged more and more, losing each day more its characteristics and structural properties.

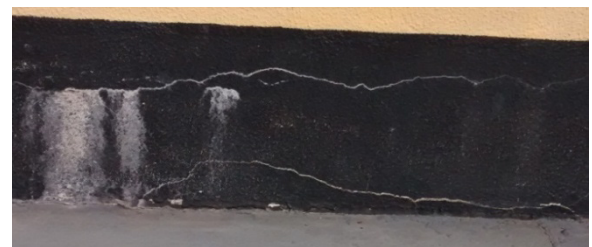
Figure 12. Building F

No less important is Building F (Figure 12), in which cracking may have occurred in several ways, among them: beam deformation due to some use overload, or even soil thickening, causing all structure movement. Because masonry has low tensile strength, creating cracks is inevitable.

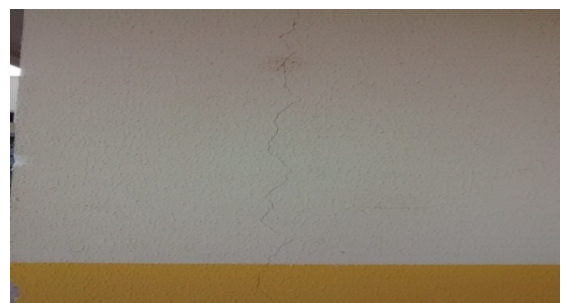
Figure 13. Building F

The soil movement is something that must be taken care of, especially in the region where the soil has low resistance and very high water table. In Figure 13, where the foundations settlement together with possible thermal movements in structural elements can cause cracking. In the case in question, cracking is present in structure, in which it gives evidence of pillars joint presence, where among them the cracking occurred due to the mortar retraction and in structure displacement, being of primary importance its monitoring by virtue of responsibility that the pillar has, for example, transferring all the efforts of the slabs and beams to foundation elements.
