Assessing Dungeness River Functionality and Effectiveness of Best Management Practices (BMPs) Using an Ecological Functional Approach

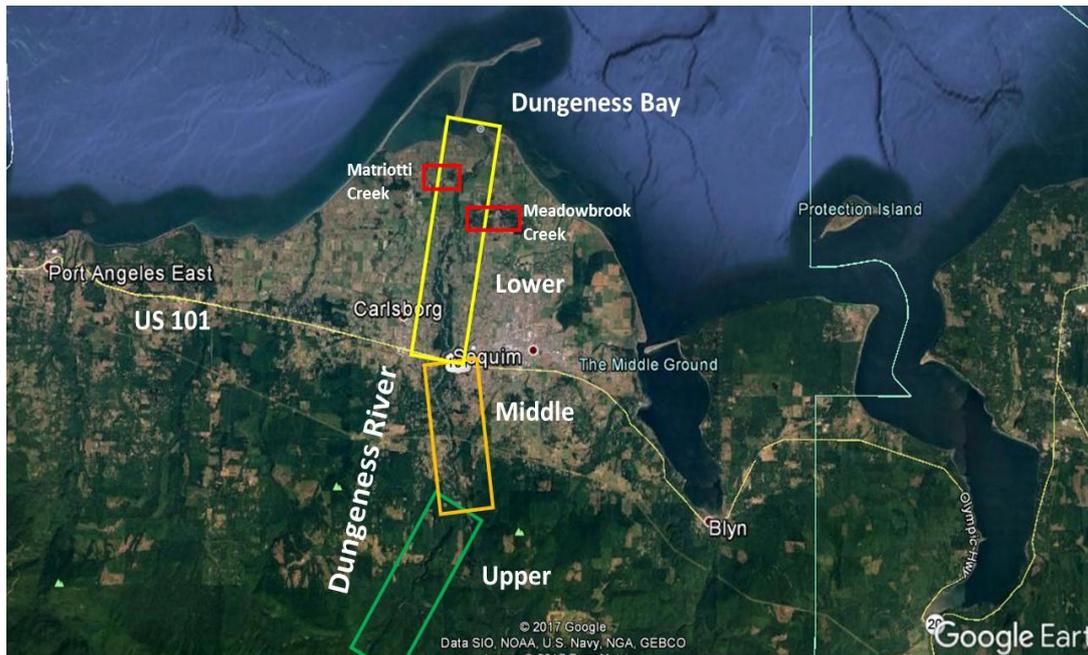
Figure 1a. Location map of the Dungeness River study area and its reaches. The Upper Reach is located on USFS land, which was assessed at the higher end of ‘Functional-At-Risk’ (FAR), green box. The Middle Reach extends from the USFS boundary to US Highway 101 and was assessed as FAR (dark yellow box). The Lower Reach extends from US 101 to the shore zone, and was assessed in the middle one-third of FAR (light yellow box). Matriotti Creek and Meadowbrook Creek were assessed as being in the lower one-third of FAR (red boxes). Composite aerial image is from Google (Data SIO, NOAA, US Navy, GEBCO). Image © 2017 Terra Metrics

Upper (upstream of the USFS boundary), Middle (USFS to US 101), and Lower (US 101 to shoreline) (Figure 1a), and matches the USFS [42] assessment of the Upper Dungeness River, and Middle Dungeness River [2]. The remote sensing and historical reports were used to display and describe the changes over time caused by human activity and provide context for the overall assessment.

The Middle Dungeness River Reach extends from the USFS boundary to US Highway 101, and was assessed as being in the middle range of FAR status (shown as yellow in Figure 1a). The channel is evolving, and is expanding its flood plain within the incised channel [24], [44]. Excess sediment and water are inhibiting the ability of the vegetation to stabilize both the point and middle channel bars. Also, excess sediment has caused the stream to braid (develop small temporary islands), and in some cases, to have an anastomosed (connected) channel pattern [45]. However, the riparian zone is widening, and the vegetation is an excellent source of large woody debris, which is useful in trapping sediment, diverting high and low flows, and in providing cover and shade for aquatic organisms [54].

Matriotti Creek and Meadowbrook Creek were assessed as being in the low end of FAR status to 'Non-Functioning' (shown as red in Figure 1a). Both creeks have been channelized because of agricultural practices and urbanization, which has reduced their sinuosity (ability to wander back and forth across the floodplain, in an 'S-shaped' pattern), and the streams' ability to migrate laterally. Riparian areas are narrow, and appear to be inadequate to protect banks, and dissipate energy, during high flows. Human activity has caused this situation, and proper management can be used to improve the trends.

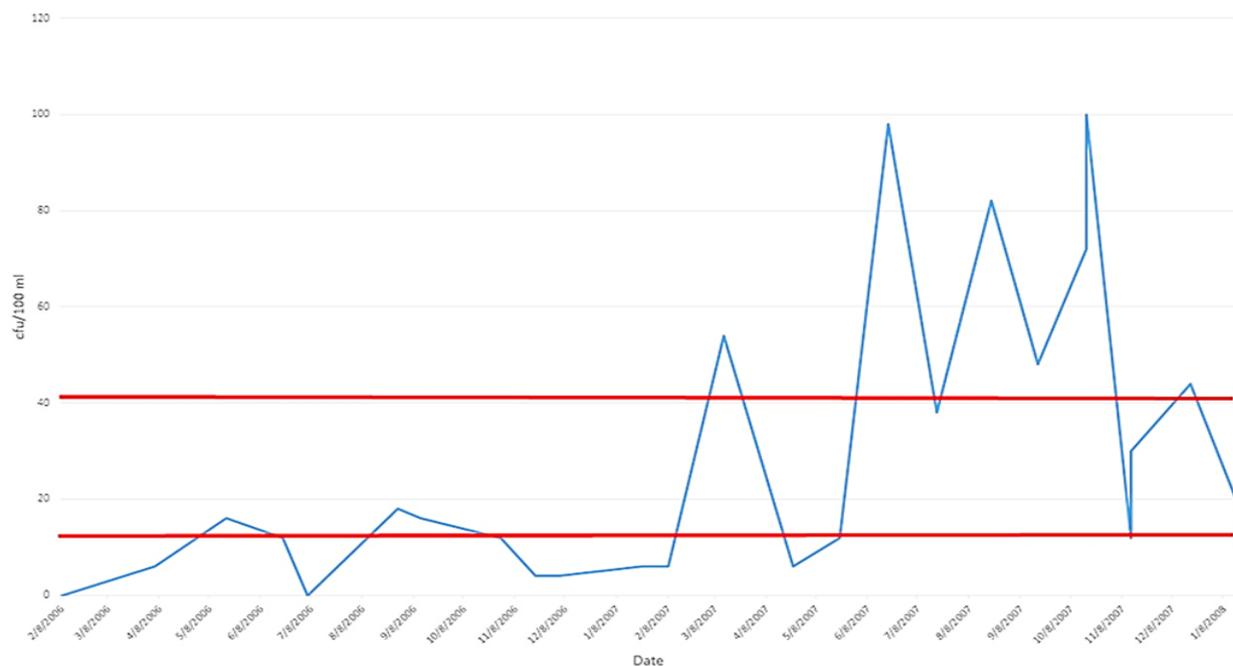
Fecal Coliform Concentrations (in Colony Forming Units (CFU) per 100 milliliters) at DUN 0.05 Station: Feb 2006 – Jan 2008

Figure 2. Fecal coliform concentrations at the State of Washington monitoring station, DUN 0.05, at the mouth of the Dungeness River (Monthly sampling from February 2006 to January 2008). To protect shellfish harvesting in the Dungeness Bay, the Dungeness River fecal coliform standard is 13 colony forming units (cfu)/100 ml (lower red line), and should not exceed 43 cfu/100 ml (upper red line), where cfu represents the colony-forming units of bacteria found in a sample. The tributaries to the Dungeness Bay should meet the current Class AA freshwater standard of a geometric mean of 50 cfu/100 mL [38]

As seen in Figure 2, the fecal coliform concentrations at the mouth of the Dungeness River were low, then subsequently in early 2007, fecal coliform concentrations begin to increase. In Matriotti Creek (Figure 3), the TMDL-associated corrective actions show an impact in lowering the fecal coliform concentrations (except for mid-to-late-summer spikes). However, on average, Matriotti

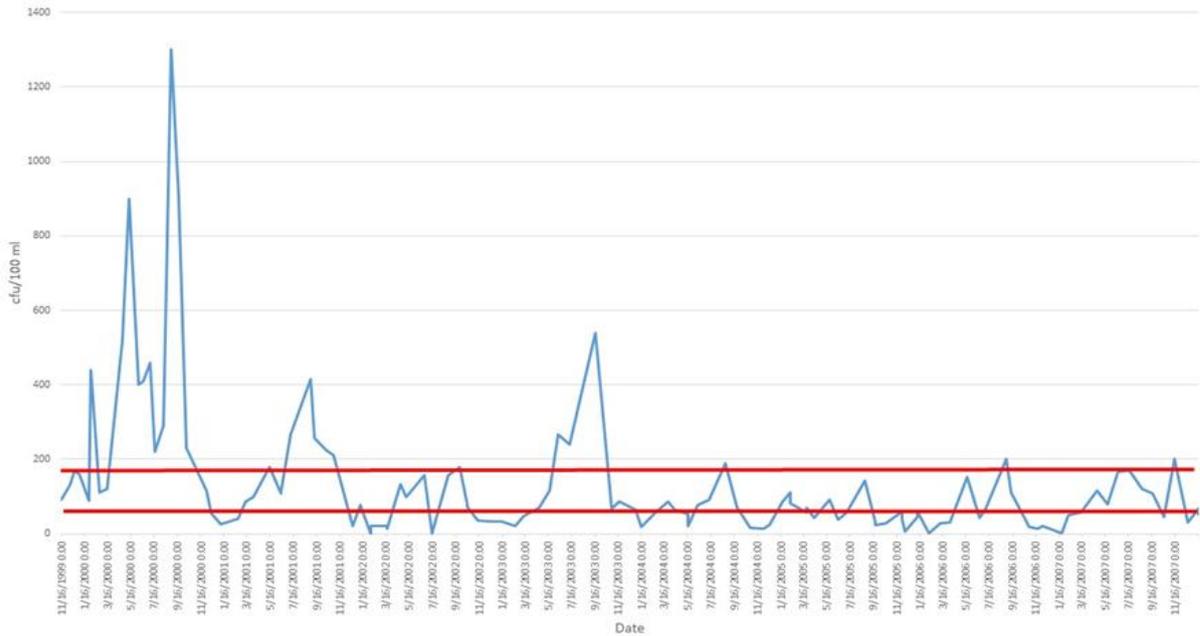
Fecal Coliform Concentrations (in Colony Forming Units (CFU) per 100 milliliters) at MAT 0.01 Station: Nov 1999 – Jan 2008

Figure 3. Fecal coliform concentrations at the State of Washington monitoring station, MAT0.01, at the mouth of the Matriotti Creek (Monthly sampling from November 1999 to January 2008). To meet the TMDL target in the Dungeness River, the fecal coliform bacteria concentrations for the Matriotti Creek needed to meet a water quality standard of 60 cfu/100 ml (lower red line), and not exceed 170 colony forming units (cfu)/100 ml (upper red line), where cfu represents the colony-forming units of bacteria found in a sample

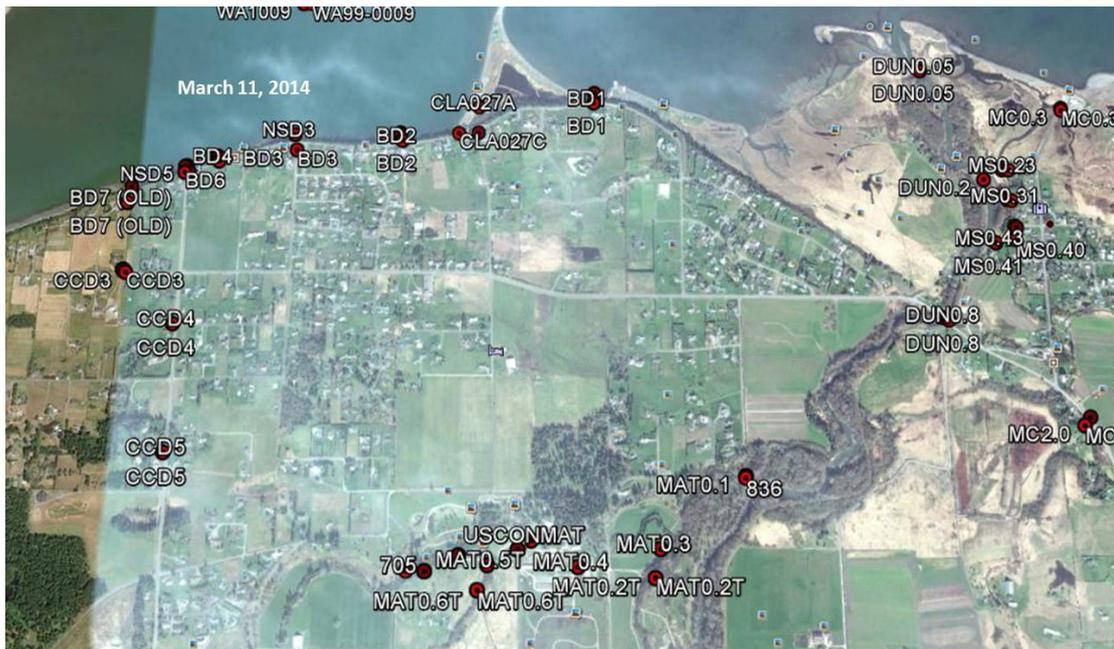
Figure 4. USDA National Agriculture Imagery Program (NAIP) March 11 2014, image of the confluence of the Matriotti Creek with the Dungeness River. Red dots are the State of Washington sampling locations. The MAT0.1 sampling site is located in the lower center-right of the image (Note the narrow riparian area along the Matriotti Creek.)

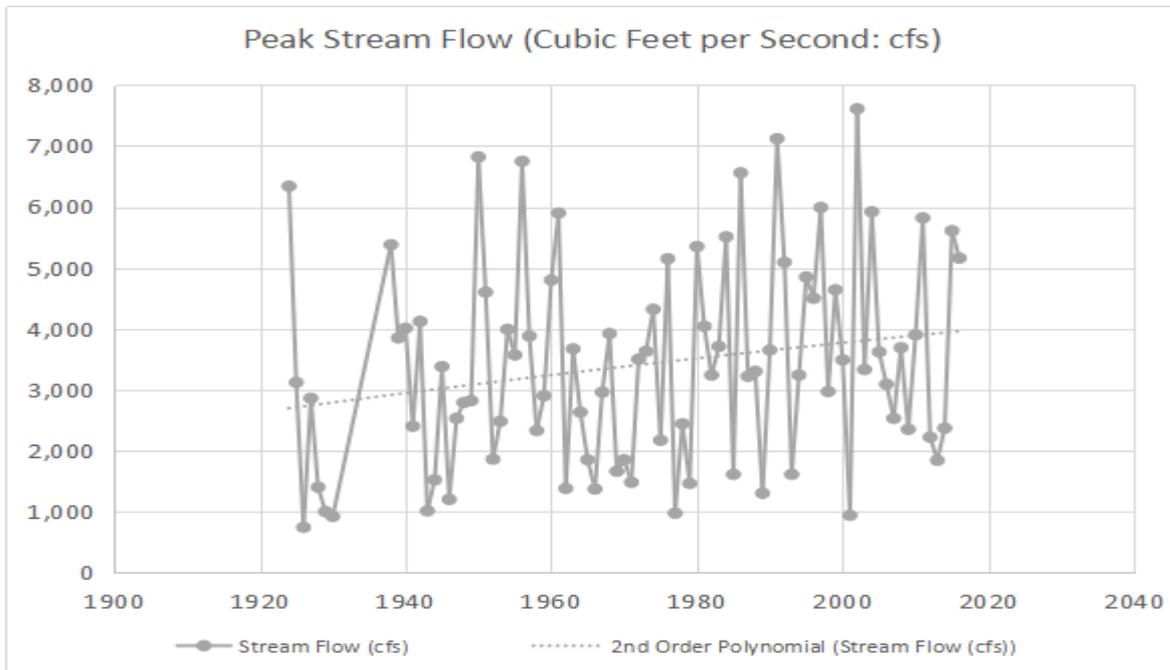
Figure 5. Dungeness River USGS hydrograph of peak flow from 1924 to 2016 (in cubic feet per second [cfs]). The trend in peak flow has increased over time. **Note:** 1000 cfs = 28.32 cubic meters per second

As seen in Figure 12A and Figure 12B, the riparian function conditions in the Dungeness River have increased to the point where the fish habitat improved. Figure 5 illustrates the higher peak flows. Figure 5 and Figure 6 display increased September base flows and average annual flows. This indicates an improvement in the physical processes (i.e., ecological functions) of the entire Dungeness River watershed.

As seen in Figures 11, 12, and 13, the change in land management may have had an effect on reducing the variability in peak flow discharge. However, if riparian functions are improving, late/dry season flow should increase (Figure 5), because more water would be stored in the riparian wetlands, and also stored as groundwater (Figure 6). The downward movement of the blue (dotted) polynomial trend line in Figure 6 indicates that either management is having an effect, or there is a change in climatic conditions such as drought, and/or perhaps more precipitation as rain, with a reduced snowpack.

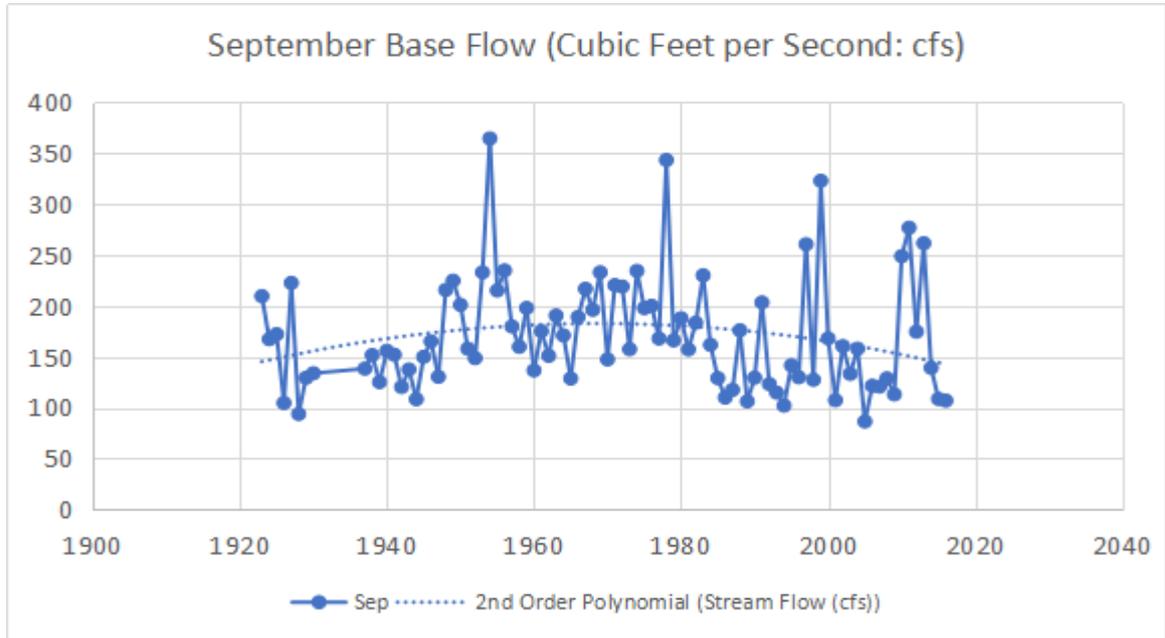
Figure 6. Dungeness River late summer (September) base flow USGS hydrograph from 1924 to 2016 (in cubic feet per second [cfs]). The annual base flow discharge increases from 1924 to 1970. Except for peak discharge years in 1955, 1978, 1997, and 1999, the variance of the base flow discharge increases over time, but is fairly stable. However, the discharge decreased after 1982, when the hatchery fish rack was removed, and this is illustrated by the (dotted) polynomial trend line. After 1982, the September base flow decreased until 2010, possibly due to climatic changes resulting in drought conditions. From 2010 to 2013, the September base flow increased, as shown by the solid line, possibly indicating a change in improved riparian functional condition, with more water being retained in the watershed, and released slowly over time. **Note:** 100 cfs = 2.832 cubic meters per second

As seen in Figure 9, the pattern of annual average discharge mirrors annual rainfall until the year 2000, when annual discharge shows less variability than annual rainfall. This also matches the September stream flow conditions in Figure 6.

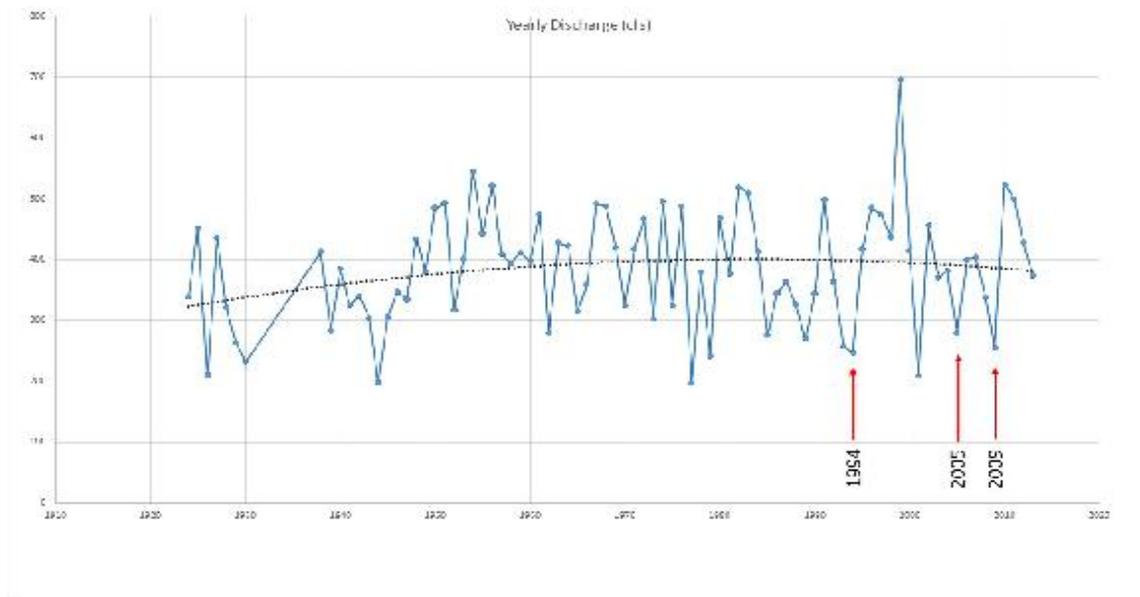
Figure 7. The hydrograph of annual discharge of the Dungeness River from 1924 to 2013. The annual average discharge (solid line) increases from 1924 to approximately 1985. The hydrograph average (dotted polynomial trend line) shows a slight decrease from 1985 to 1995, continuing to decrease until the present. Lower variability in annual discharge in the hydrograph after 2005 indicates an improved riparian functional condition, with more water being retained in the watershed. The red arrows indicate dates of satellite imagery corresponding to what is shown in Figures 10, 11, and 12 respectively. **Note:** 100 cfs = 2.832 cubic meters per second

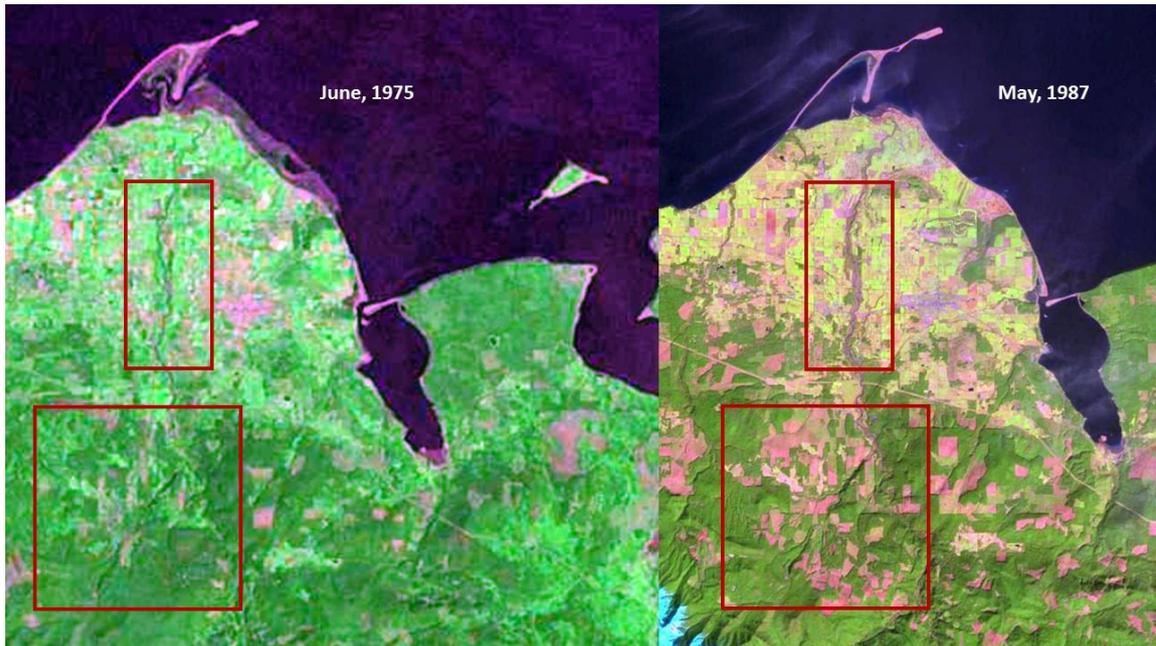
Figure 8. Landsat time series images: Left image - (A) June 1975, and; Right image - (B) May 1987. Left Image (A): The lower inset box outlines ‘clear-cutting’ areas occurring in the Upper Dungeness River/Wolf Creek area. The upper inset box shows increasing land use in, or close to, the river’s riparian zone. Right Image (B): The lower inset box displays further expansion of ‘clear-cutting’. The upper inset box shows the increased sediment load into the Dungeness River. Note: The ‘leaf out’ of riparian woody vegetation is just emergent in the May 1987 image

channel degradation. The buildup of excess sediment (seen as light-colored streaks/areas in the stream channel in Figure 8B) is shown, and is not being moved through the system. The stream channel, as shown in the top red box in Figure 8B, is straighter, north of US Highway 101 (appearing as a faint pink line through the center of the image), and has widened (Figure 8B). Figure 8 shows the impact of land use at two distinct points in time.

The long period of channel alterations along the Dungeness River, and within the watershed, increased peak flow into the channel, and also had an impact on the annual average discharge (Figure 8). The annual average discharge of the Dungeness River increased into the 1980's. Low water years in the mid-to-late 1980's slowed the transport of material through the river (Figure 8B), but peak flows were

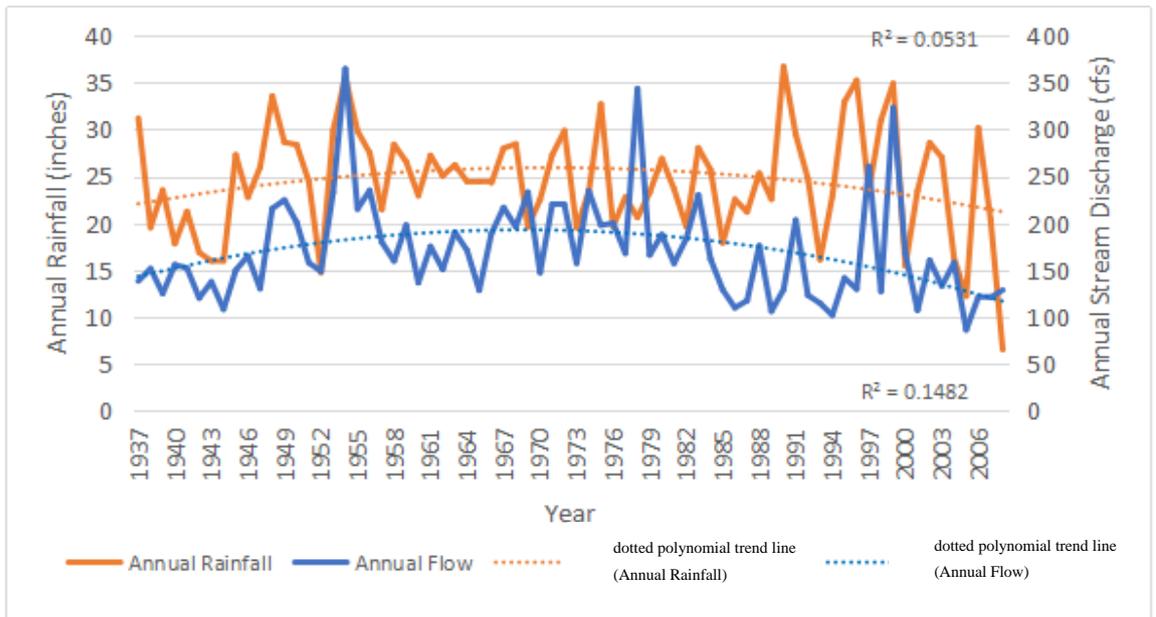
Figure 9. Dungeness River hydrograph of annual flow (discharge: blue line - in cubic feet per second [cfs]) and annual rainfall (red line: in inches) measured in Port Angeles WA, from 1937 to 2006. **Note:** 100 cfs = 2.832 cubic meters per second

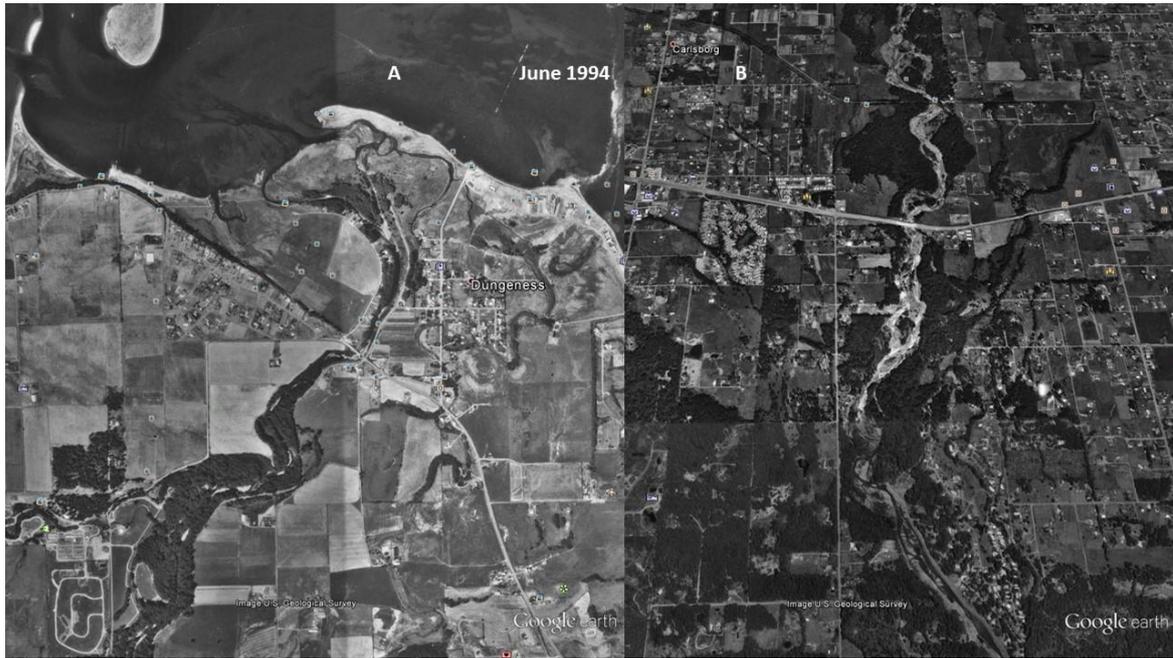
Figure 10. 1994 USDA National Agriculture Imagery Program (NAIP) image of: Left image (A), the Lower Dungeness River, and; Right image (B), the Middle Dungeness River. Left Image (A): Sinuous and multiple outlets are at the mouth of the Dungeness River. The delta and barrier spit appear to be expanding from excess sediment. Right Image (B): Incised braided stream channel extends from the Lower to the Middle Dungeness River, north and south of Highway 101. There is very little to no re-vegetation of the point bars

As seen in Figure 10, the Lower Dungeness River (Figure 10A) is channelized, and has multiple outlets to the bay. The delta and barrier spit appear to be expanding from excess sediment. The Middle Dungeness River (Figure 10B), north and south of US Highway 101, is an incised, braided stream channel, with little to no re-vegetation of the point bars. The braided stream channel indicates an excessive amount of sediment is being supplied from upstream. As seen in Figure

10, the sediment in 1994 (Figure 10B) dominates the channel morphology (as compared to Figure 11A and Figure 11B). The practice of 'clear cutting', and the friable mountain soils, are most likely causing mass wasting events, and/or consistent and chronically increasing sediment rate. The sediment also contributes to the expansion of the barrier spit at the mouth of the river (Figure 10A).

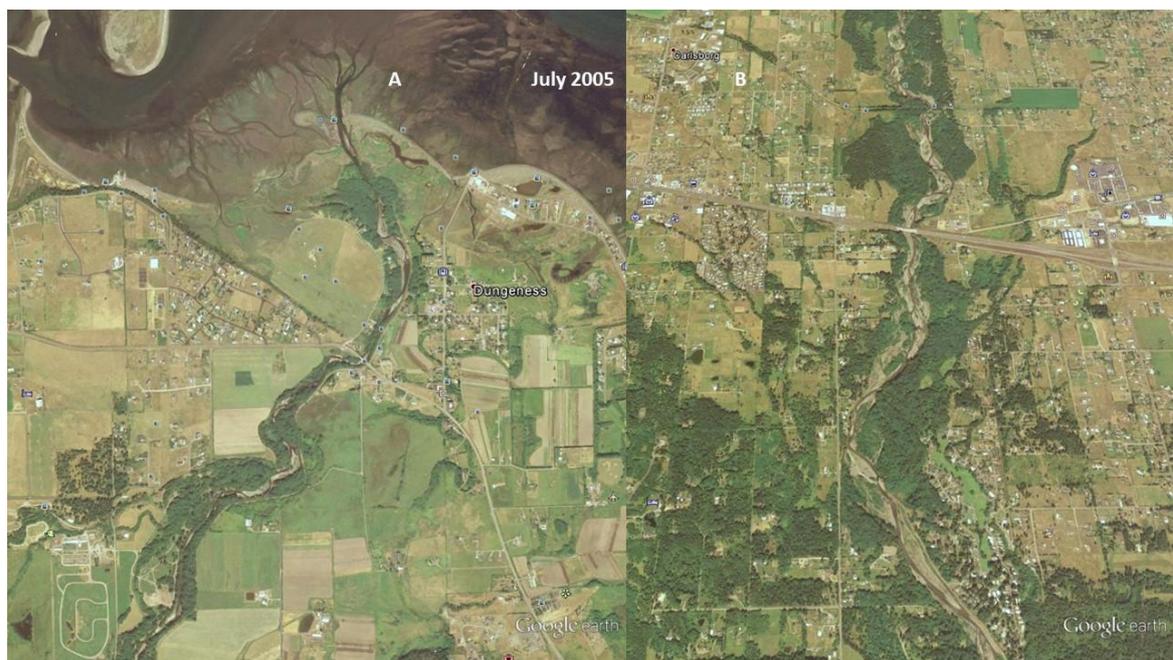
Figure 11. 2005 USDA image of: Left image (A), the Lower Dungeness River, and; Right image (B), the Middle Dungeness River. Left Image (A): Less sinuous, almost straight, mouth of the Dungeness River, resulting from high flows cutting across the barrier beach into the Dungeness Bay. The delta appears to be expanding into the Dungeness Bay from excess sediment. Right Image (B): The stream channel along the Lower-Middle Dungeness River, north and south of Highway 101, is less braided, and the point bars are re-vegetating

The USFS land management strategy change [2] took a few years to show an impact on reducing the variability in peak flow discharge. As a result, the increased channel flow (Figures 6 and 7) of the Dungeness River breached the barrier spit in late 1994, and again in late 2001. As seen in Figure 11A, in 2005, the straightened channel created an island from the former spit [43], and transported sediment further into Dungeness Bay (**Note:** Large sand waves are visible in the upper right corner of the July 2005 image [Figure 11A]).

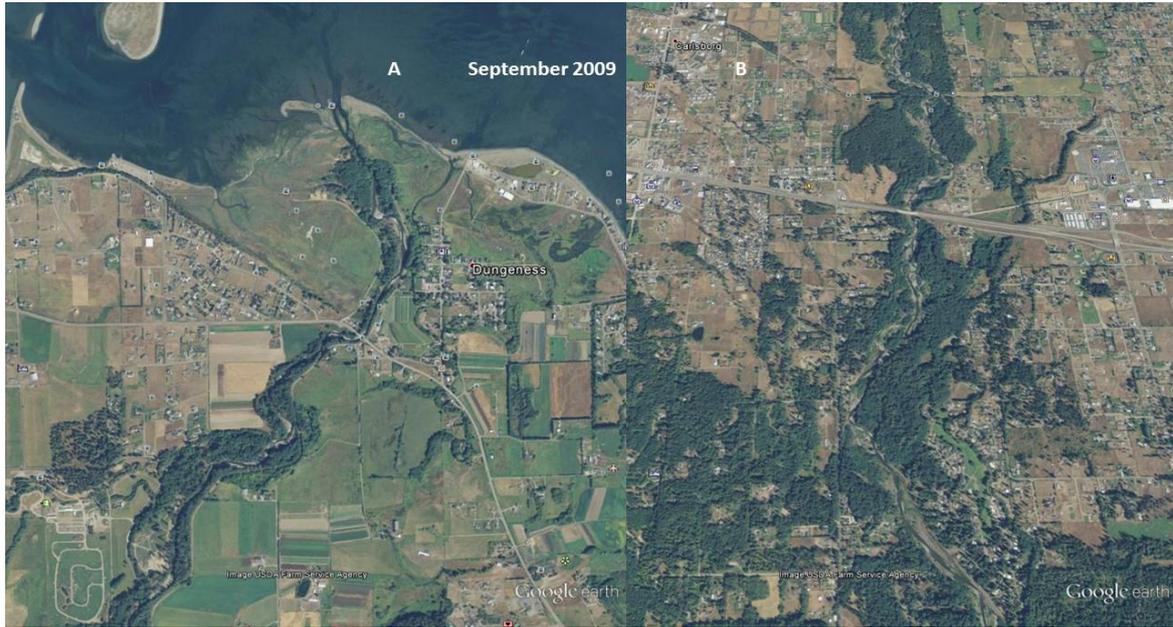
Figure 12. USDA 2009 National Agriculture Imagery Program (NAIP) image of: Left image (A), the Lower Dungeness River, and; Right image (B), the Middle Dungeness River. Left Image (A): The stream channel is straight, with a mid-channel bar. Riparian woody vegetation is expanding along the bend. The barrier spit is decreasing in size. Right Image (B): The Lower-Middle Dungeness River, north and south of Highway 101, has now become a single channel, and riparian vegetation appears to be stabilizing the point bars

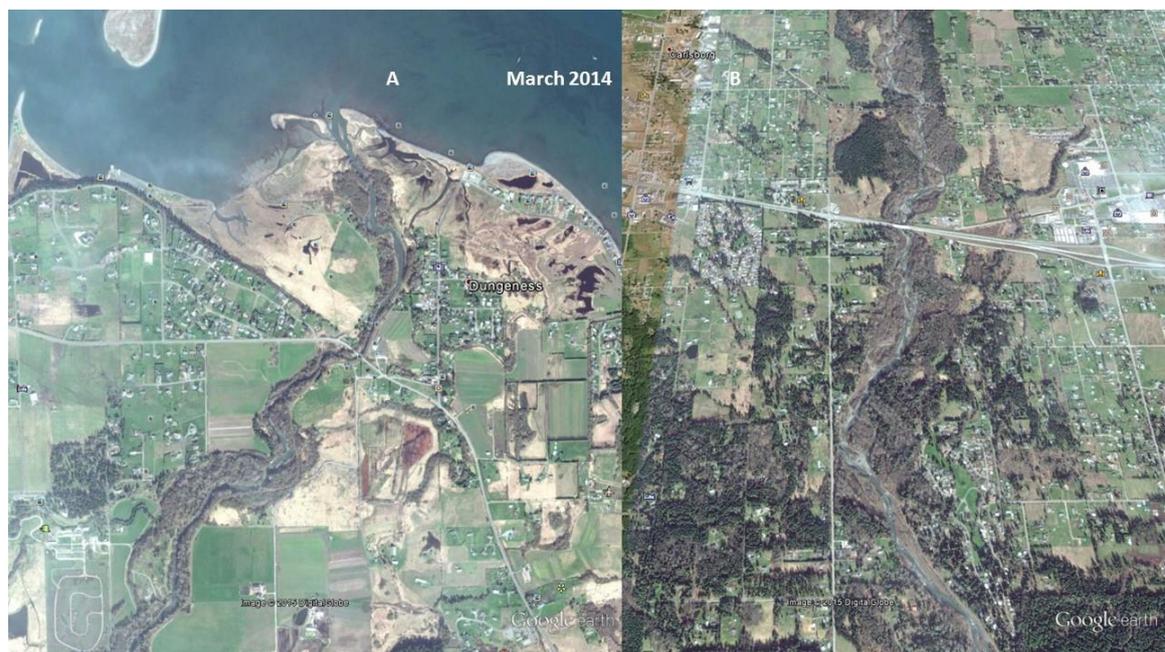
Figure 13. 2014 USDA National Agriculture Imagery Program (NAIP) image of: Left image (A), the Lower Dungeness River, and; Right image (B), the Middle Dungeness River. Left Image (A): A single wide channel discharges into the Dungeness Bay. The barrier beach and spit have decreased in size, indicating a decrease in sediment reaching the bay. The back-beach lagoons are enlarged. Right Image (B): The riparian vegetation has stabilized the Lower-Middle Dungeness River point bars, reducing the amount of sediment reaching the Dungeness Bay
