Comparison of Natural Frequency Vibration Analysis for a Bridge Using Accelerometers and a Piezoelectric Cable Vibration Sensor

N. Shimoi^{1,*}, M. Saijo², C. Cuadra¹, H. Madokoro¹

¹Department of System science and Technology, University of Akita prefectural, Yurihonjo, Akita, Japan

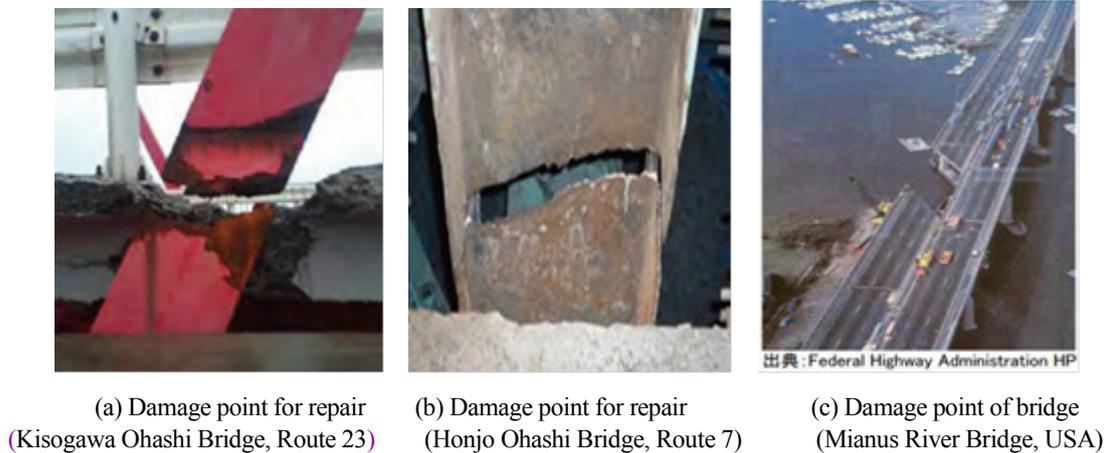
Figure 1. Old damaged bridge and maintenance examples in Japan and the USA

Catastrophic disasters of this type would have been avoided if adequate safety measures such as establishing examination routines and setting laying sensors had been taken. Figure 1 presents bridge damage in Japan and in the USA.

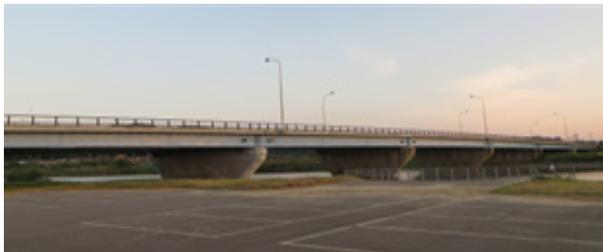
Figure 2. Target bridge for measurements (Asuka Ohashi Bridge). The bridge comprises seven spans having total length of 256 m. Experimental measurements were taken of the first span near the left abutment

A monitoring system meeting the Ministry of Land, Infrastructure, Transport and Tourism requirements must have some important features: (1) Data obtained using the system must be readily comparable to prior inspection results. (2) The system must be universally applicable to any site to work effectively. (3) The system must show any infrastructural changes after a disaster such as an earthquake. (4) The system must reduce costs of maintenance and be labor-saving [5]. Figure 2. presents bridge for measurement.

Asuka Ohashi Bridge, a reinforced concrete (RC) bridge over the Koyoshi River, a class A river, was completed in 1979. Its eight bridge columns and seven spans give it maximum span length of 38.0 m.

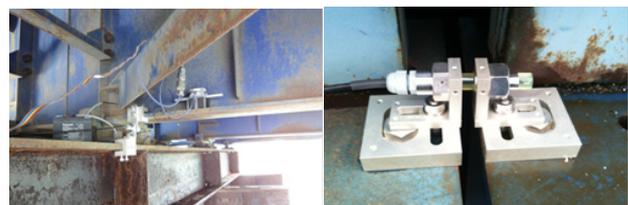
(h) Sensor measurement method for temporary bridge

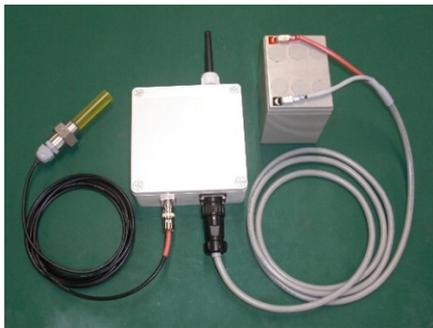
**Figure 7.** Piezoelectric vibration sensor for structural health monitoring system

We inserted piezo-cable 80-mm-long into the center of hollow cylinder of urethane resin ($\phi 15 \text{ mm} \times 80 \text{ mm}$) and fixed it using adhesive to produce a cylindrical sensor similar to a bolt as depicted in Figure 6 [18]. Jacketed lead wire of 4-mm-diameter and 1.5 m long was connected to the sensor and insulated. It was later wired to single-board computer. The sensor outputs voltage corresponding to cable deformation sent to processing devices of our system that measured displacement and vibration caused by cars and other vehicles passing over the bridge. This design

concept underpins our simple measuring system portrayed in Figure 7.
