The Tilting Problem of AL- Khulafa Mosque Minaret

Abstract The protecting of ancient structures is considered a very important issue as these represents the heritage of the countries. Hence, the performance and the effect of the surroundings changes around such structures have to be understood. In this study, an investigation was performed for the problem of tilting the minaret of the AL-Khulafa mosque in Baghdad, which is tilted about 1.5 m. Detailed geophysical methods were applied to detect the tilting problems of the minaret foundation. Three tests were carried out; ground penetration radar, soil electrical resistivity, crosshole seismic and triaxial tests. The results showed that the water seepage under/around the minaret due to dewatering process around the mosque have a major source for the problem. This groundwater mixed with sewage material, is found to move towards municipality pump that is located nearby the mosque fence within 35 m distance. The tests showed the apparent spread of cavities and soft zones under/around the minaret foundation. Finally, the shape and depth of foundation were able to explore from crosshole test, which is extended to a depth of 8.5 m.

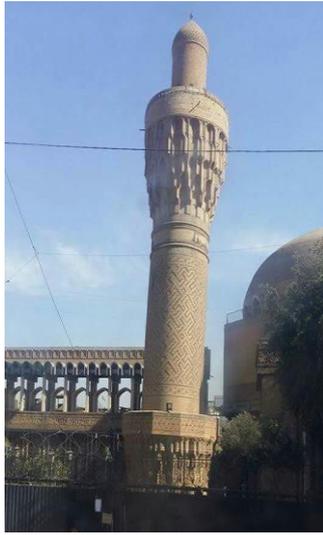
The historical minaret of the Al-Khulafa mosque, as shown in Figure (1), built in 1279 AD, has a height of about 34 m. The minaret itself is surrounded by a courtyard 13.0 x 14.0 m. It has been modernized and restored to a cylindrical

shape so that it contains a collection of decorations and beautiful forms. Inside the minaret there are two helical stairs that rotate inside the minaret's body in opposite directions. The Al-Khulafa minaret is influenced by dewatering process for many years back from the surrounding area around the mosque.

Figure 1. Tilting Minaret of Al-Khulafa Mosque, Built in 1279 AD

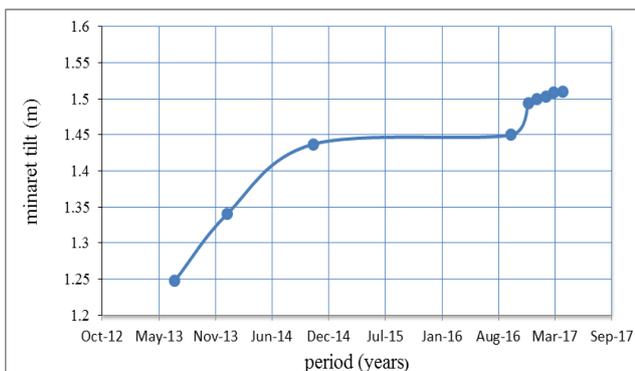
The date of the minaret's inclination was not specifically known, the first survey for the minaret was done in 2013 with inclination of 1.24 m. Later, in recent years, the inclination has gradually increased especially in last two years as shown in Figure (2). In 2017, the observation survey have conducted for each month, the monitoring showed that the inclination was increasing from (5-10) mm /month.

Figure 2. Measured Horizontal Movements of Minaret between 2013 and 2017

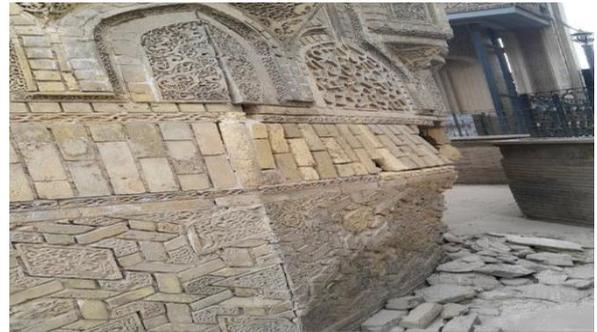
It was found during the site visits for the minaret large failures in the masonry decoration especially at the tilting side as shown in Figure (3), as a result from changing in centre of gravity location of the minaret and generation of

high moment on foundation soil and finally developing a lot of cracks in the body of the minaret. Also, it was found that the minaret suffered from seepage of water, especially during the winter/rainy season where the water remains constant at about 20-25 cm height at backyard area surrounding the mosque. Another impressive case is noticed; from the dewatering process of nearby buildings, houses and shops around the minaret. Finally this process causes increasing the effective stress of soil and led to a settlement of foundation of minaret, because of decrease in buoyancy. The development of stress will be associated with strain. The rate of settlement is based on the stiffness and stress history of soil. The process of dewatering is considered very large in the area surrounding the minaret and is estimated at hundreds of cubic meters per day. Also the plumbing leaks and/or broken water lines; plumbing leaks under or near foundations can saturate soils around it and potentially weakening their load-bearing capacity of soil. Often, plumbing leaks push soil out from under the foundation, creating a void below minaret foundation or any structure foundation causes the tilting or sinking.

Figure 3. Failures in masonry decoration of tilting side of minaret

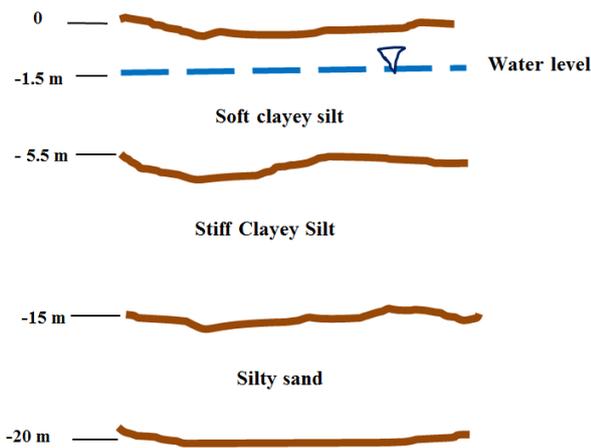
Two geotechnical boreholes were drilled to a depth of 20 m. Laboratory tests were achieved to determine grading, consolidation, shear strength parameters. From field inspection and laboratory testing the following geotechnical soil parameters are listed in Table (1). The test boring showed that, generally, the soil profile is consist of three layers, as shown in Figure (4) the upper layer is considered soft clayey silt, extends to depth of 5.5 m, followed by a layer of stiff clayey silt, this layer extends to a depth of 15 m. Then a layer of medium sand is exist extend down to the end of

boring 20 m. Groundwater levels have been recorded at the end of boring in the next day and found to be at depth of about 2.0 m below ground level.

Figure 4. Soil Profile below the Minaret Foundation

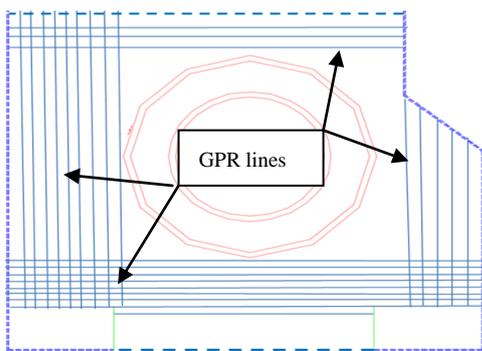
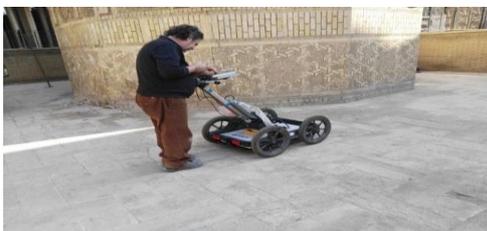
Figure 5. Locations of GPR Profiles around the minaret

Figure 6. GPR Survey at Al- Khulafa Mosque Site

Ground penetrating or probing radar (commonly called GPR) is a high resolution electromagnetic technique that is designed primary to investigate the shallow subsurface of the earth, building materials, roads and bridges [6]. GPR is relatively new geophysical tool that has become increasingly popular due to its high resolution and the need to better understand near-surface conditions, [7]. The test was performed in the form of longitudinal and transverse sections to cover all the ground area around the minaret to get a plan that shows profiles weakness under the surface and lateral extension of the foundations and a depth of at least 3 m and is referred to in Figures (5), (6).

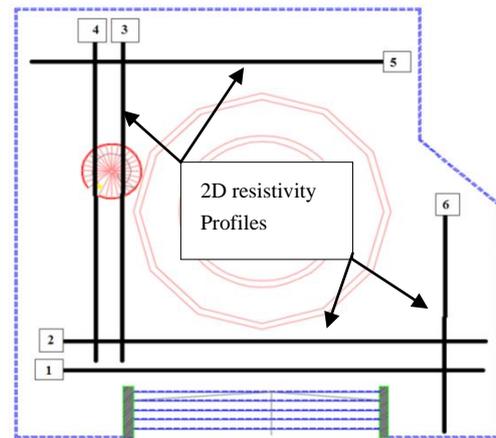
The resistivity imaging survey was carried out around the minaret along six profiles as close as possible to the minaret. This survey is chosen as a complementary method to the GPR since the GPR method has some limitations in conductive soil. The test was performed in the form of six profiles by making holes in the ground near the minaret as shown in Figure (7).

Figure 7. Locations of the Surveyed Resistivity Profiles around the Minaret

In the Figure (7) previously shown, the profiles (3 & 4) gave important results about upward subsurface soil movement. The profile 3 starts from the top side, as shown in Figure (16) the first resistivity layer shows cavitation and fractures particularly at the middle parts. While the first few meters show water saturation that reaches the ground surface. The second layer (blue and dark blue) represents saturated filling materials. The third layer (green to brown colors)

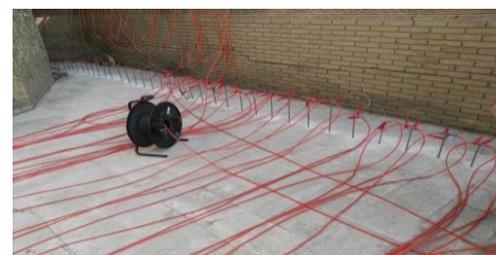
The work has included drilling the holes with a diameter of 1 cm and depth of 15 cm by use a portable drilling machine, then inserting the electrodes in holes with a distance of 25 cm between them as shown in Figure (8).

Figure 8. Electrodes Distribution at the Minaret Site

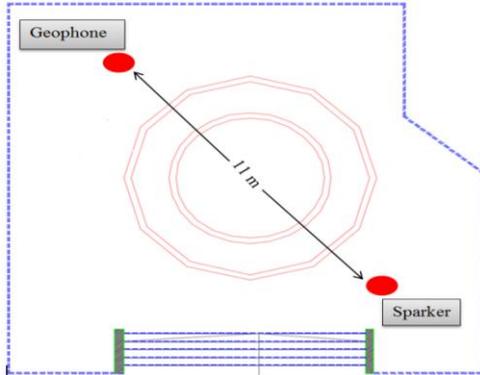
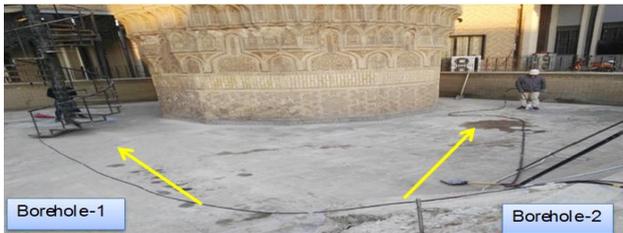
site. This survey determines shear and compressional wave velocities versus depth profile. From these measurements, soil physical parameters can be determined. The down hole system consists of a borehole source, capable of generating shear and compressional waves, and a five component geophone receiver. ASTM D-4428 standard is followed in this test [8]. The source and the geophone are lowered to a depth of (12.0 m) in the two boreholes at about 11.0 m apart on a line as shown in Figures (9) and (10). The measurements are taken stepwise at every 0.25 m intervals up to the top of the boreholes.

Figure 9. Borehole Geophone at Borehole -1 and Sparker at Borehole -2

Figure 10. Locations of the Boreholes

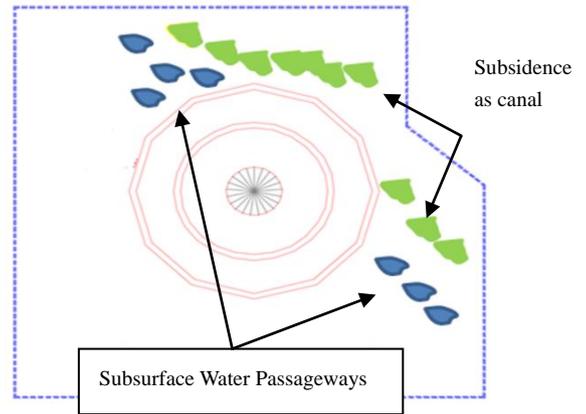
The final results of the GPR survey are represented in Figure (11). The locations of the buried water passage ways (blue spots) are also shown along with the areas of subsidence. In Figure (12) the possible subsurface water seepage directions are represented. These are plotted according to the water levels differences that were detected in the GPR radar grams.

Figure 11. Main Subsurface Features that Detected by the GPR Survey: The Blue Spots Represented Subsurface Water Passageways and Green Represented loose Soil and Subsidence

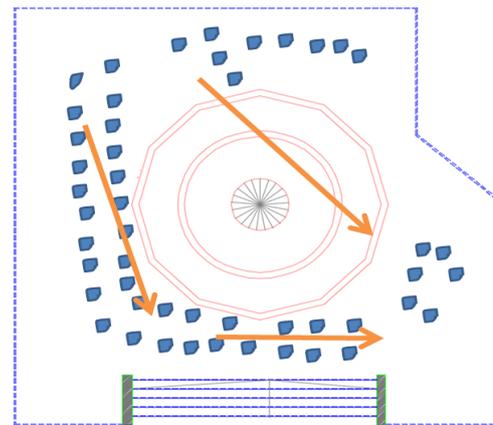
Figure 12. Possible Groundwater Movement Directions from GPR Test

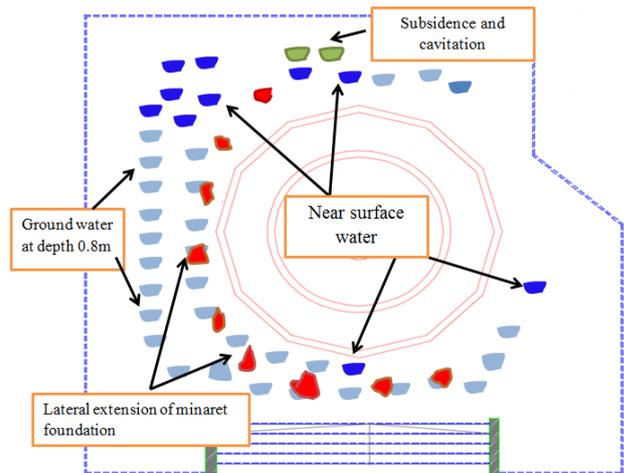
The results of surveyed resistivity lines are shown in Figure (13). The main subsurface features are plotted on the minaret layout as a sketch, which also indicates the possible lateral extent of the minaret foundation. Figure (14) showed the underground water movement directions are indicated, which is agreement with the results obtained in the ground radar penetration test in Figure (12). Through these tests, it was found that water movement comes from the back areas surrounded by the mosque; then moves towards the minaret and then changes its direction to the adjacent area of the mosque (i.e. towards the municipal's pump). The municipal's pump is located within 35 m from the side the mosque, as shown in Figure (15).

Figure 13. Main Subsurface Features of Soil Resistivity

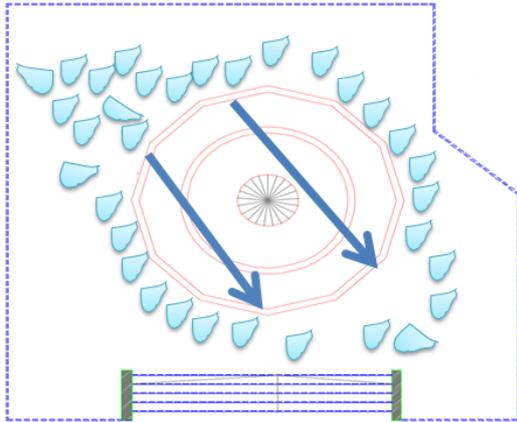
Figure 14. Possible Groundwater Movement Directions from Electrical Resistivity Test

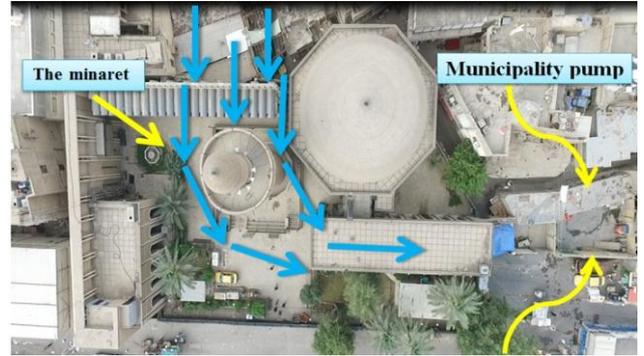
Figure 15. Aerial Photo of the Pump Location and Direction of Water Movement

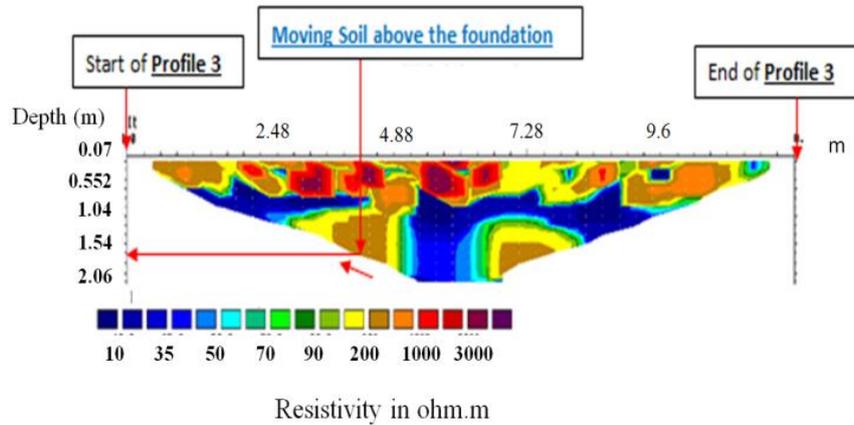
corresponds to the outer extent of the minaret foundation or the old natural soil. Apparently there is upwelling of the soil/foundation material at this side of the minaret foundation.

Figure 16. Apparent Resistivity in Profile 3

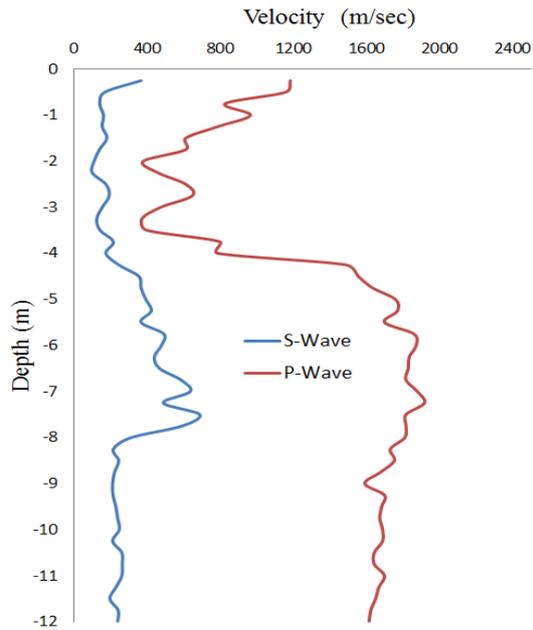
Figure 18. Variations of P-wave and S-wave Velocities with Depth

The result of crosshole depending on the velocities of P-wave and S-wave were calculated depending on the first arrival times and the horizontal distance between sparker and geophone boreholes, in Table (3) the typical values of shear and compression wave are shown for different soil [9]. It measured P-wave and S-wave velocities along the 12.0 m, the soil profile show clearly three main values ranges as shown in Figure (18). The first values range starts from depth 12.0 m to 8.0 m; the second range is between 8.0 m to 4.5 m depth; and the third range is from 4.5 m to 0.25 m. The top

0.25 m corresponds to surface concrete and tiles layer. For the calculated shear modulus, also shows three ranges more clearly. The shear wave velocity (S-wave) is more sensitive for the rigidity, and particularly the horizontal component of this wave type. The final values expressed in Figure (19).

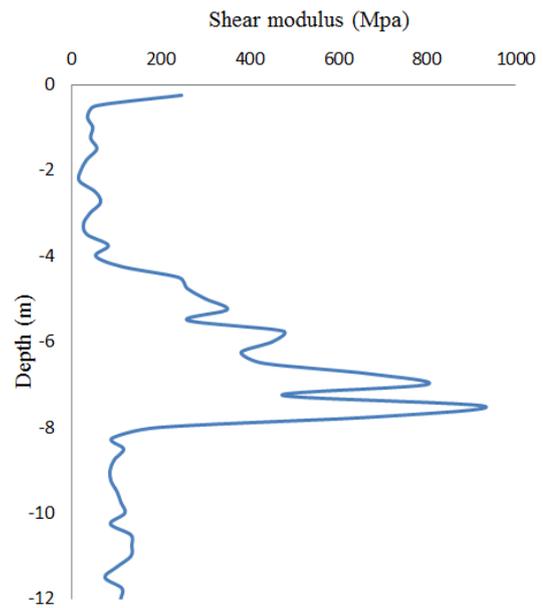
Figure 19. Variation in Dynamic Shear Modulus with Depth

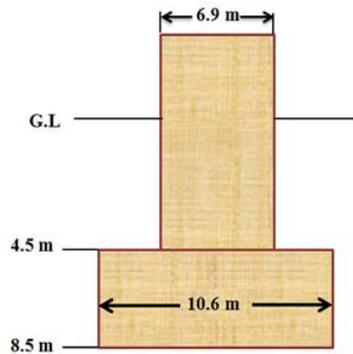
Finally, the geophysical surveys showed that minaret foundation reaches a depth of 8.5 m from the ground surface. At depths from 0 m to 4.5 m the foundation diameter is around 6.9 m, at depth 4.5 m to 8.5 m the foundation diameter is around 10.6 m. This is surrounded by the old natural soil and filling materials. Figure (20) shows a sketch for the details of the minaret foundation shape. The seismic cross-hole test showed non-homogenous physical stiffness of the foundation bricks. It seems that the

Figure 20. Shape and Depth of the Minaret Foundation belowground Level

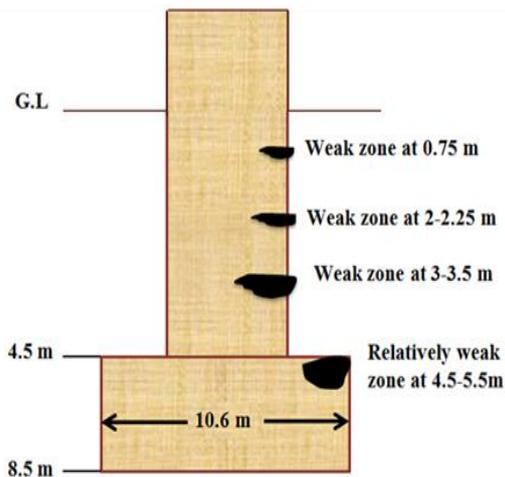
foundation bricks at depth 4.5 m to 5.5 m lost their rigidity. This is possibly due to the effect of the groundwater movement and the biological and biochemical reactions with minaret brick. At depths from 3 m to 3.5 m and at 2 m to 2.25 m the soil and the foundation bricks showed weak properties. It seems that the maximum corrosion, erosion, biochemical effects are concentrated to these depths. Figure (21) shows the possible weak zones within the minaret foundation depending on the seismic crosshole test results.

Figure 21. Weak Zones Location with the Minaret Foundation as Deduced from Seismic Crosshole Test
