Assessment of the Condition of an Existing Marine Concrete Structure in the Niger Delta Region of Nigeria

Abstract Chloride induced reinforcement corrosion is the major cause of premature deterioration of reinforced concrete structures in the chloride-laden Niger Delta region of Nigeria. This study evaluated the extent of deterioration of an existing 45 years old concrete quay structure. The methodology adopted for the study includes conducting a visual inspection on the structure to determine the current condition of the structure and the nature of testing required. Next, several non-destructive tests were carried out to determine the compressive strength, nature of corrosion and the impact on the structure. Water samples were also collected for chemical analysis, to ascertain the corrosion inducing compounds present in the surrounding seawater. The results indicated that the quay structure suffered from chloride-induced corrosion, imposed by the surrounding seawater. Measurement of the level of corrosion carried out on steel reinforcement samples obtained from the quay showed a high-level of corrosion, with rates of 0.65 uA/cm^3 , evident by an average weight loss of 47% per met

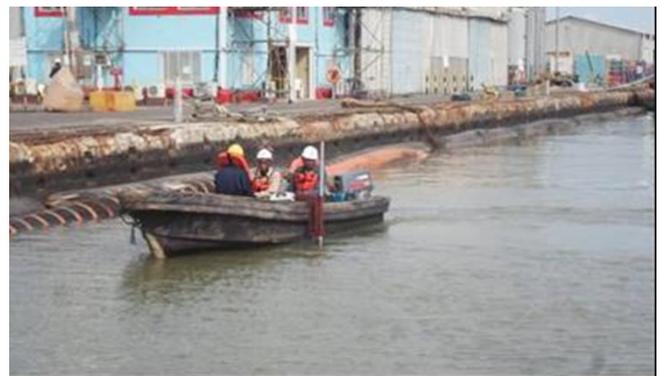
Figure 2. Survey/inspection team on a boat carrying out the investigations

of distress such as cracking, spalling and rust-staining. These signs may be indicative of various distresses [16]. The inspection was conducted using a boat to identify deteriorating areas where detailed observations and documentation of the structure's condition needed to be carried out (see Figure 2). For much deteriorated areas, special attention was paid to the structural system and modifications, (if any). Suspected areas of deterioration as well as presumed structurally sound areas were identified and marked with indelible marker pen. Extensive photographs of the quay structure were taken to document and identify the extent of investigation required and the types of tests needed. Surface defects including cracks, honeycombing, rust staining, efflorescence, spalling, exposed reinforcement and other type of defect encountered were documented and photographically illustrated for representative areas.

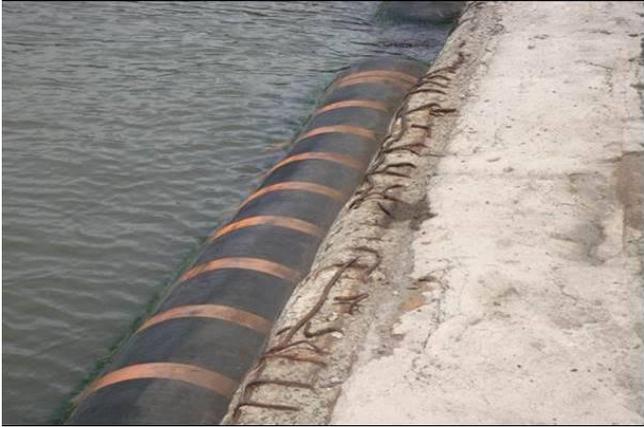
Figure 4. Corroded steel reinforcement bars at quay edge beam

Visual inspection carried out on the quay revealed various signs of distress on the structure, such as cracking, concrete spalling and rust staining (see Figures 4 and 5). There were signs of corrosion of reinforcement and exposure of originally embedded steel reinforcement in more than 40% of the surface area of the quay deck and face. Spalling of concrete cover was observed in large and multiple sections of the deck surface and on the edges of the slabs, which indicates signs of severe corrosion of the underlying reinforcement. Spalling of the concrete further led to exposure of the steel reinforcement to the environment, and the creation of a clear path for the ingress of chloride ions and other aggressive ions to the steel reinforcement. These impacts were observed to be more on the concrete exposed to the tidal zones, as compared to those exposed to atmospheric and splash zones.
