Repair Methods Indication for a Timber Coverage Structure Located in Sinop City - Brazil

In the middle of this scenario, the study by proposed case was held in the Central-West region of Brazil, State of Mato Grosso, in the city of Sinop, specifically covering structure of Sinop Forest Park (11°50'5.5" S; 55°30'4.2" W). The main objective was to identify and to diagnose the nature and types of causative agents of pathologies instituted in the structure under study and, subsequently, to suggest appropriate methods curative and preventive (prognosis) to promote an increase in lifetime of the structure.

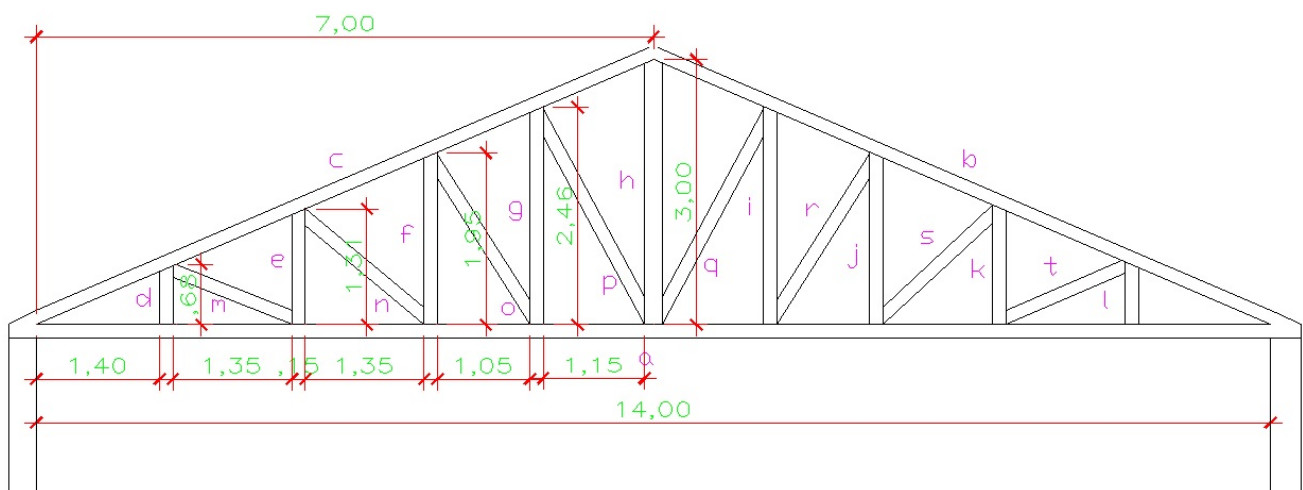
Figure 1. Geometry of the lattice (schematic)

- Length of the structural elements (Figure 1);
- Connections: metal hook (between central stud and inferior chord); nails (among other studs and chords); notch (between diagonal and chords); sheet metal and through-bolts (amendments of the chords);
