Historic “HAUFF” Timber Roofs in Poços de Caldas in Brazil

Abstract This research presents the assessment of historic structural systems timber roofs type “Hauff” of constructions existing in Poços de Caldas, Minas Gerais, Brazil. The large timber structures originated with the engineering company “Hauff”, whose production of timber structures contributed in great measure to the technological advance of the industry of construction engineering with wood in Brazil. Based on photographic by techniques of visual inspection (NDT) and descriptive documentation, this paper offers examples of timber roof structures that constitute most of type “Hauff” roof structural systems, such as, lamellar roof structure, sawn lumber nailed arch, plywood arch, shed truss roof, that were built between the years 40 and 60 in the city at Poços de Caldas in Minas Gerais. The timber structures with “Hauff” were built in various regions of Brazil at that time.

Current Assessment of timber roof structures type "Hauff", in Poços de Caldas

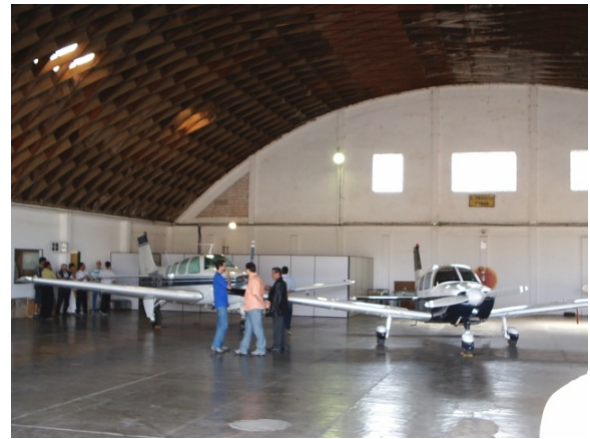
(a)

Inside view of the hangar.

Details of lamellar roof: moisture migration from tiles.

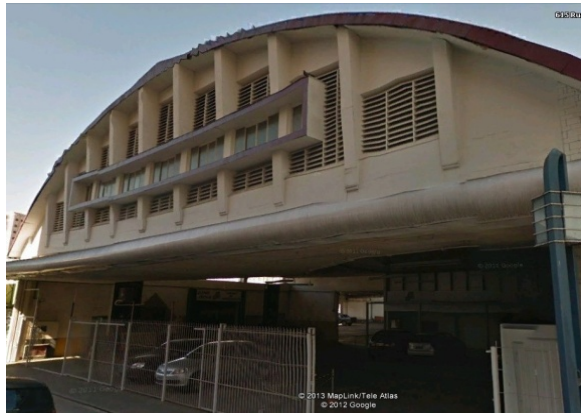
(a)

Roof RTH-02: Plywood arch ~30 m of span.

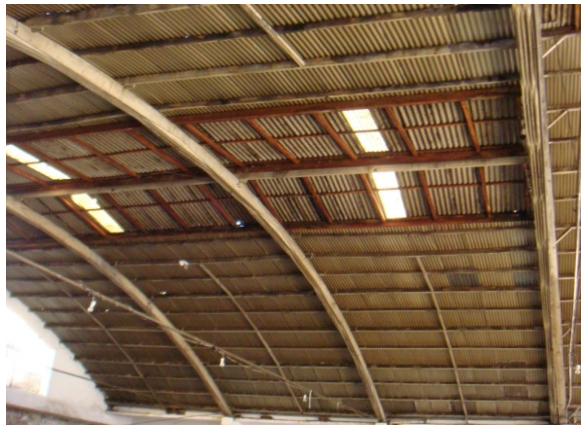
(b)

Roof RTH-03: Vertical sawn lumber nailed arch ~ 30 m.

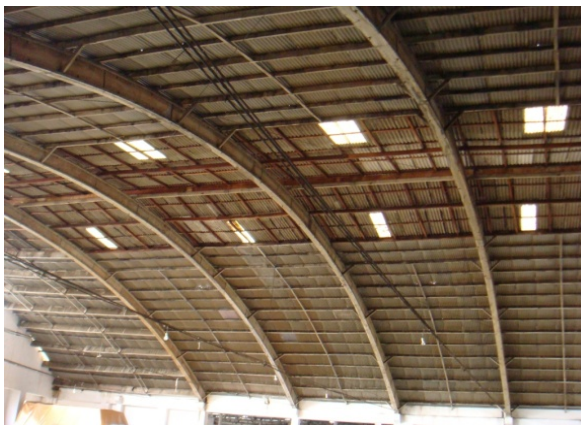
(a)

Roof RTH-04: Plywood arch ~ 45 m of span.

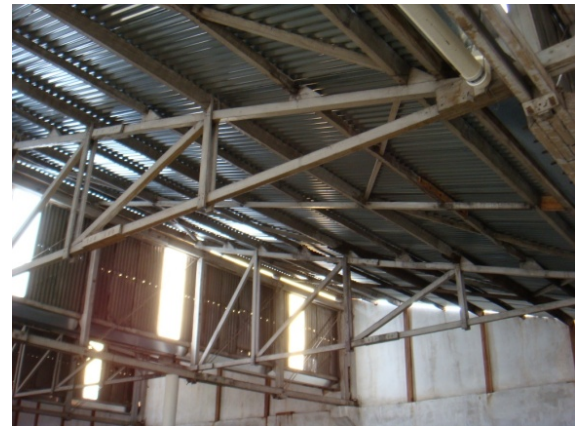
(b)

Roof RTH-05: Shed truss roof ~ 20 m.

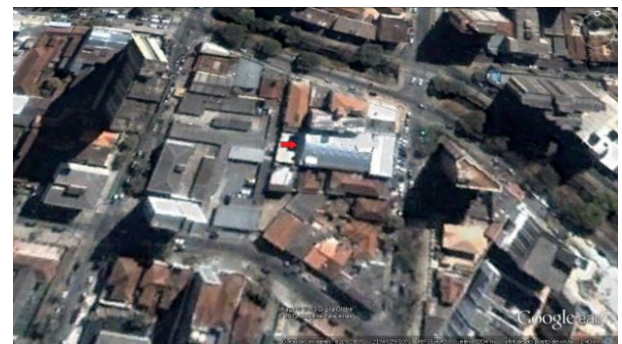
(a)

The roof here identified by RTH-06 (Figure 4a) known in the scientific-technical, has structural system type plywood arch, with approximately 20 meters of span. This roof is situated on GPS coordinates 21° 47' 29,10"S; 46° 33' 48,19"O; and altitude of 1204 meters, [Google Earth].

RTH-06: Plywood arch ~20m of span.

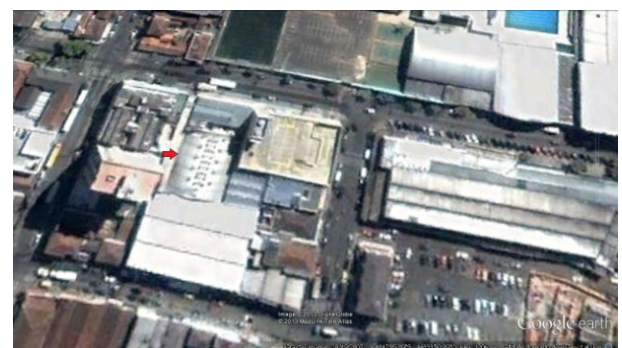
(b)

The roof here identified by RTH-07 (Figure 4b) known in the scientific-technical, also has structural system type Plywood arch, with approximately 40 meters of span. This roof is situated on the GPS coordinates 21° 47' 05,90"S; 46° 33' 50,05"O; and altitude of 1204 meters, [Google Earth]. However it was not possible to photograph details of these

roofs, because they were coated with PVC lining. Therefore, it was observed that the wood pieces were paintings with enamel in green, and the structural elements presented in excellent condition, including metal rods.

RTH-07: Plywood arch ~40m of span.

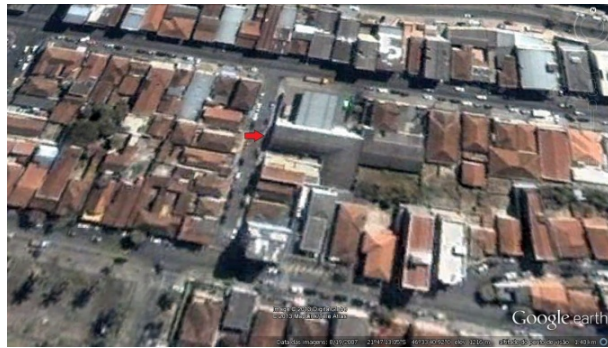
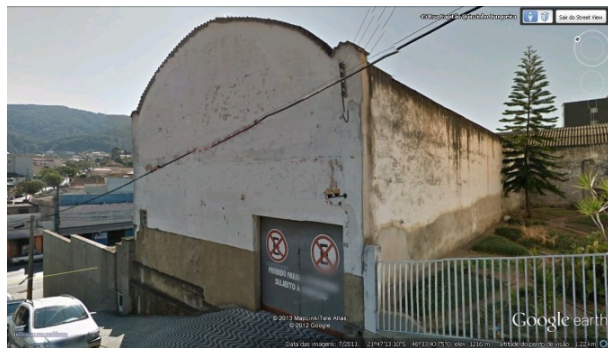
Figure 5. Warehouse with timber roof structural system: RTH-09. Source: [Google Earth]

The roof RTH-08 (Figure 5) has structural system type sawn lumber nailed arch, with approximately 15 meters of span. But it was also not possible to photograph details of this roof. This roof is situated on the GPS coordinates 21° 47' 13,10"S; 46° 33' 40,75"O; and altitude of 1216 meters. The leasing plan of this building is in L.

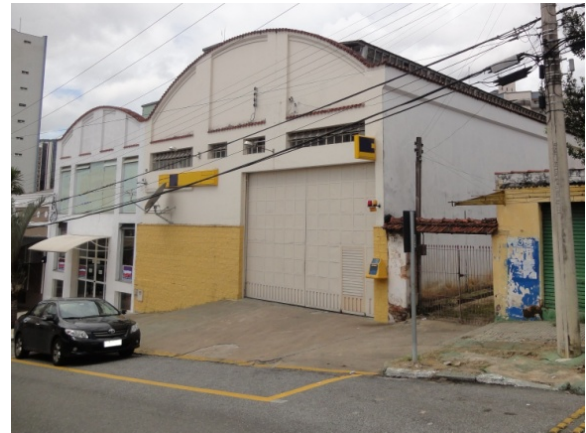
(a)
Warehouses germinated: RTH-10 e RTH-11.

The roof RTH-10 is located at GPS coordinates $21^{\circ} 47' 33,09''S$; $46^{\circ} 33' 52,41''O$; and altitude of 1210 meters. The roof RTH-11 is located in the GPS coordinates $21^{\circ} 47' 32,58''S$; $46^{\circ} 33' 52,31''O$; and altitude of 1209 meters. The buildings of these roofs corresponds to 2 warehouses germinated (Figure 7a). The roof RTH-10 has structural system type plywood arch, with approximately 16 meters of

span, and with skylight central projection of natural light (Figure 7b). The wooden parts of the roof RTH-10 were with enamel paintings in gray, and the structural elements and metal rods, presented in excellent condition.

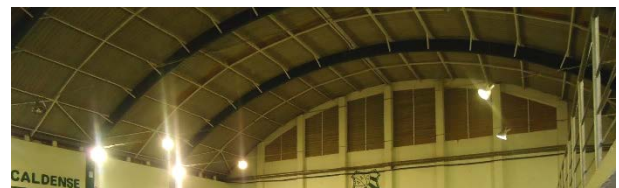
Figure 8. Roof RTH-12: Structural system type plywood arch ~ 30m

The roof RTH-12 (Figure 8) of Gymnasium of the Club's "Caldense Athletic Association" has roof structural system type plywood arch, with approximately 30 meters span. This roof is situated on the GPS coordinates $21^{\circ} 47' 06,30''S$; 46°
