SEM Based Studies on Damage Analysis of GFRP and CFRP Sandwich Composites

Abstract Sandwich composites possess higher directional properties and are made of relative lower density core which makes them ideally suited for light weight applications. In the pursuit of better material selection for aerospace application, effects of damage modes resulting from Low Velocity Impact on aircraft structures are little explored since the damages arising from tool drop, debris effect during runway and bird hit may result in BVID – barely visible impact damage. The main aim of this paper is to detect and record the impact damages in structures made from GFRP and CFRP sandwich panels made from Polyurathene foam core. A SEM – scanning electron microscope was used to assess the type and level of damage on the panels with impact energies – 9.81J, 29.43J and 49.05J in turn inspect the topography at higher magnification. The resulting out come from SEM analysis were matrix cracking, fiber fracture and delamination / dent on the sandwich panels. The core material chosen for the analysis was PU foam type with densities 70kg/m³, 100kg/m³ & 200kg/m³ with a constant thickness of 14mm. It was found that s

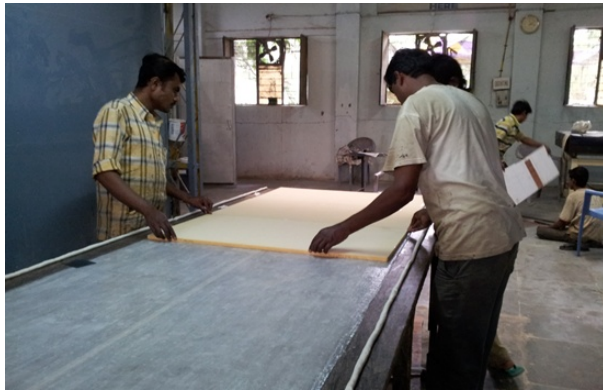
Figure 1. Sandwich panel fabrication

The sandwich specimen used for this investigation was made from GFRP and CFRP facings with PU foam core of densities – 70kg/m³, 100kg/m³ & 200kg/m³. The resin used for the sandwich construction is Epoxy Resin with a combination of 10:1 ratio – LY556 resin and HY951 hardener. The sandwich composite were fabricated with a 1mx1.5m panel as shown in figure 1 and in turn were post cured for about 2 hours at 60°C and later cut with a dimension of 150mmX150mm using a diamond saw for both GFRP and CFRP sandwich composites. The top and bottom facings were maintained at 1mm.

dimensional accuracy before being tested. The core material was kept constant at 14mm.

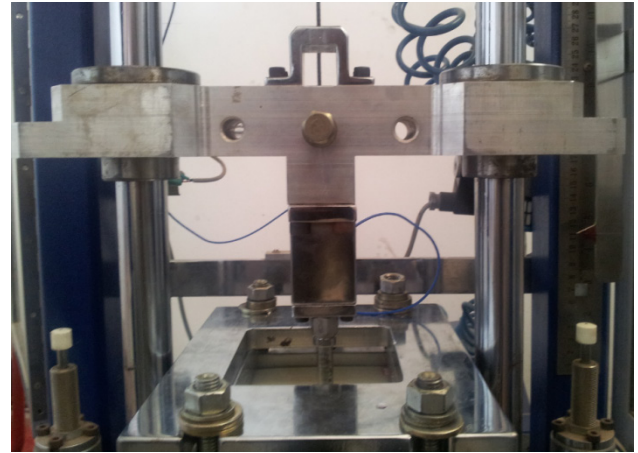
Figure 2. Low Velocity Impact testing machine setup

A low velocity impact testing (LVI) machine (falling weight drop test) was chosen for impact analysis. The velocity of impact chosen for the test ranges from 1.401, 2.426, 3.132 m/sec for all densities selected. Different mass of impactor of 2.5, 5 and 10kg is selected with hemispherical indenter. The impact energies with a range from 2.45J to 49.05J was selected for the test. The specimen was clamped with all degrees of freedom fixed and an impact region of 100mmX100mm was exposed for the impact test. The impactor was raised for different height and in turn was dropped to determine the impact energy absorption capacity. A free fall (frictionless) along the guide rails was ensured

and the results were recorded using DAC – digital acquisition card, which can capture all signals from the piezoelectric setup mounted on the test setup. Details such as energy absorption, depth of penetration (displacement), max load during impact are recorded.
