Linear Regression Models to Evaluate Characteristics of Railway-Roadway Level Crossings in a Developing Country

Weerahennadige Suren Hemal Romesh Fernando, Niranga Amarasingha *

Department of Civil Engineering, Sri Lanka Institute of Information Technology, Malabe, Sri Lanka

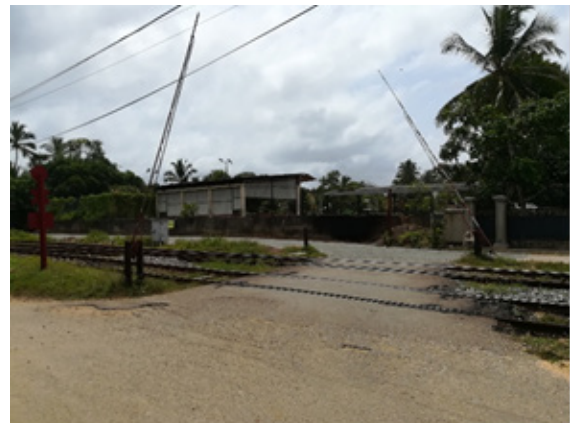
Figure 1. A Level Crossing in Sri Lanka

A level crossing is a location where a railway and a roadway, or two railway lines, crossing at the same level on the ground [2]. Figure 1 shows a protected level crossing equipped with a gate in Wadduwa, Sri Lanka.

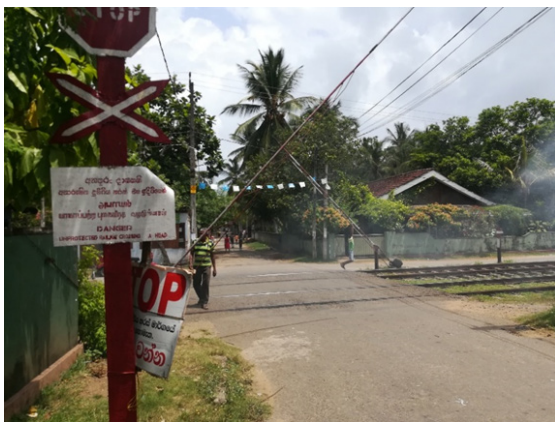
Figure 2. A Crossbuck found in Sri Lanka

Passive level crossings are road-rail crossings that are only protected by warning signs and are normally found on roads that have less traffic. Warning signboards fall into this category. A passive level crossing notifies that the railway-roadway crossing is a dangerous place and road users should be careful at all times. It warns the road users to expect an approaching train and to always give priority to the train if it comes without trying to outrun it. Accidents are more likely to occur at passive crossings because the vehicle drivers on the road may not identify the approaching train [5]. The main passive control systems are the warning boards and signs indicating the position of a level crossing. Crossbucks are among one of the most used passive safety systems. These are found around the world and even in Sri Lanka as shown in the Figure 2. In the United States (USA), the back to back crossbucks are used on each of the railroad intersection [6].

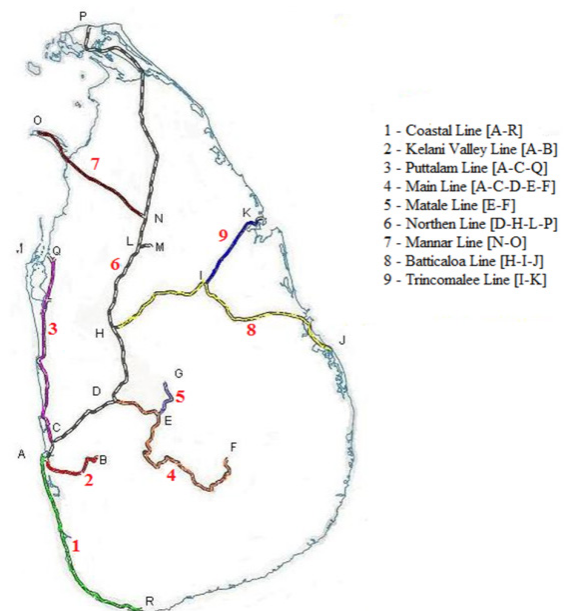
Figure 3. Railway Network in Sri Lanka

There are reported 1,186 level crossings throughout the country and out of these only 130 are protected with an Automatic barrier, 155 are protected with bell and flashing lights, 140 are protected with lever operated barriers and only 17 are protected with wing type gates. Today the SLR is divided into three operating regions based in Colombo Maradana, Nawalapitiya and Anuradhapura. At present, there are nine important railway lines in Sri Lanka as shown in Figure 3 [1].

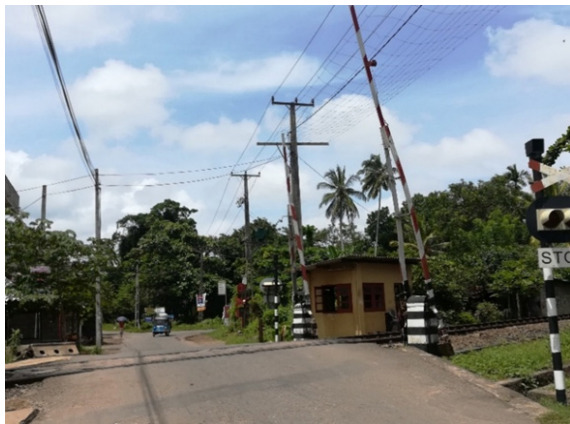
Figure 4. Barrier Equipped Mechanical Level Crossing in Sri Lanka

In Sri Lanka, four types of protected level crossings exist: farm gates, mechanically operated level crossings, automatic bell and light systems, and electrically operated barrier systems. Farm gates are protected by gates on both sides of the railway and are completed with the farm type gate when closed across the railway track. Mechanical level crossings are situated in locations having heavy traffic density. They are progressively interlocked with signals and planned basis by gatemen. Automatic bell and light systems have no barriers but are protected by road traffic light signals and an audible warning. Electrically protected crossings are protected by road traffic light signals and a lifting barrier on the side of the roadway on both sides of the railway [1]. Figure 4 shows an active level crossing equipped with a mechanical barrier protection situated in Hettimulla, Sri Lanka. Protected level crossings are consisted of permanent gates. Unprotected level crossings in Sri Lanka consist mainly of two types which are level crossings equipped with GI gates and level crossings which do not have any gates or warning signs. The GI gate level crossings are maintained by the Sri Lankan Police. The protected level crossings which are the permanent gates are maintained by the SLR.

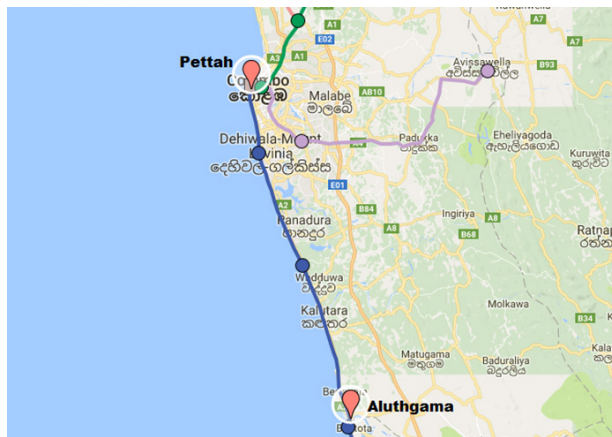
Figure 5. The Existing Railway Line in the Study Area

The study area of this project was limited from Pettah to Aluthgama along the coastal railway line. Figure 5 shows the railway line in the selected study area. The distance from Fort railway station to the Aluthgama railway station is 59.6 km. The coastal line is also referred to as the Southern line and it runs between Colombo Fort and Galle. The total line length is 157.88 km and 61.9km of line has a double track from Colombo Fort to Kalutara South and the remaining length is a single track from Kalutara South to Galle.

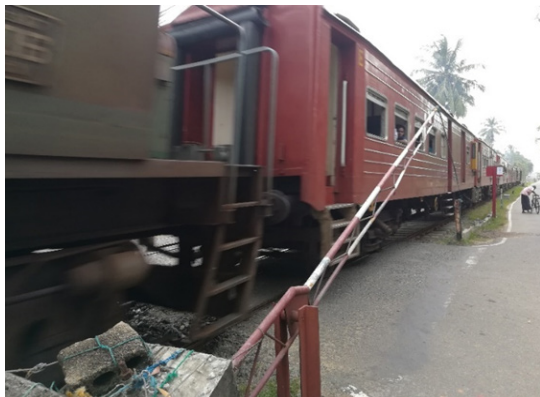
Figure 6. Partially Closed GI Gate

According to the collected data, 43% of level crossings were equipped with GI gates. GI gates are operated manually and therefore this requires a gate operator to be present. Furthermore, the gate operator should be aware of the arrival time of trains on this track. Watching on train and watching the train signal are the only observation techniques used by the gate operators in order to close the gates. Some gate operators knew the exact arrival time of the train by experience and use this past experience to close the level crossing gate on time. During the field observations it was found that the pay received by a GI gate operator was a sum equivalent to 2 US Dollars per day. Interviewing the gate operators revealed the fact that most of them were complaining about their wages and this was keeping them less enthusiastic about this important job. It was observed that at some locations, the gate operators only partially closed the gate. Motorcyclists could easily go through the partially closed gate and this carelessness could lead into fatal crashes. Figure 6 shown below illustrates a partially closed GI gate situated in the study area.

Furthermore, it was noted that though the gate operators closed the gates, some drivers would ask them to open it since the train was not in sight. These types of behaviours could cause fatal crashes especially in level crossings where the visibility of the train is not clear. The GI gate operators should be educated with proper safety programs in the dangers of performing such acts. A salary increase of even at least a small amount is also suggested since it would motivate the operators into doing their job properly since the presence of a careless gate operator who does not perform their job well is the same as not having one at all.

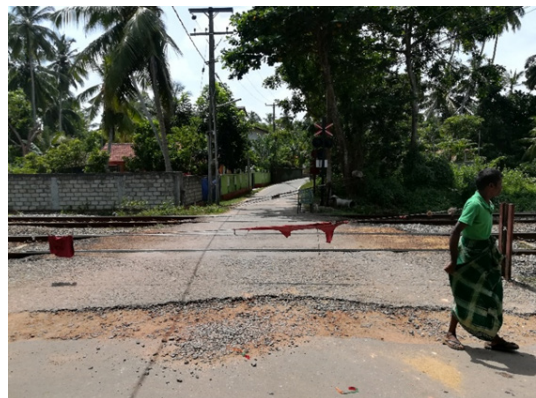
Figure 7. A GI Gate replaced with Rope and Red Cloth

Figure 7 shows a GI gate which does not exist due to the lack of proper maintenance. The gate has been replaced by a rope and red cloth. Considering the sight distance from the seaside, 31% had a moderate sight distance and 10% of level crossings had a bad sight distance. Considering the sight distance from the land-side, 16% had a bad sight distance and 27% of level crossings had a moderate sight distance. Vehicle drivers are unable to suddenly control their speed while approaching a level crossing. Therefore, in such low sight visibility areas, pave rumble strips or asphalt bumpers on the road surface should be made in order to control the vehicle approaching speed. Since there are unprotected level crossings with bad sight distance, this step would help in giving the vehicle driver time to observe the level crossing before crossing it.

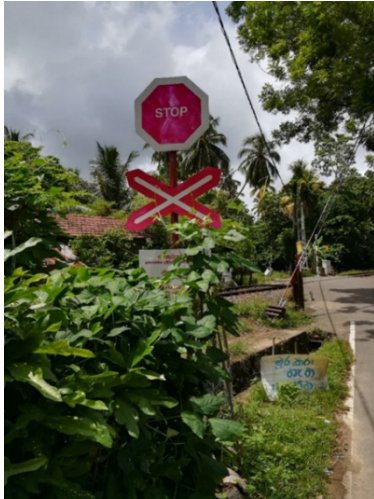
Figure 8. Safety Signs fixed too close to the Level Crossing

During the field observations, it was confirmed that the most of the warning signs and safety sign boards were fixed too close to the railway-roadway level crossing. This kind of placement affects the perception reaction time of the drivers and it contributes to the occurrence of a fatal crash at an unprotected level crossing with bad sight distance. For example, Figure 8 shows a low sight distance level crossing near Aluthgama with safety signs fixed too close to it.

Though the level crossing in Figure 8 has GI gates, it does not have an operator thus making it an unprotected crash prone location. This type of situations should be avoided.
