Assessment of Pull-through Failure of Nail Connection for Rural Roofing System under Wind Load in Malaysia

Abstract Roof collapse due to wind load impact on roof sheeting during thunderstorm event was reported by media. In most cases, failure of roof sheeting based on two points, either on material roof sheeting or at connection of roof sheeting. It was observed that the most failure of roof sheeting is likely occurred for non-engineered building. Base on MS 1553:2002 wind load for building structure, structural elements should be able to resist wind speed up to 32.5 m/s. Therefore this study is conducted to identify the possibility of the pull-through failure of nail connection with Corrugated Galvanized Iron (CGI) roof sheeting for non-engineered buildings. This study is focus on the connection between roof sheet metal and nail connection with various spacing between the connections. Finite Element Method was used in this study to analyse and identify the load distribution. From the result it shows that the maximum spacing of nail connection is 480 mm to resist the wind load recommended by MS 1553:2002. From the result it can be concluded that as the spacing of connection increa

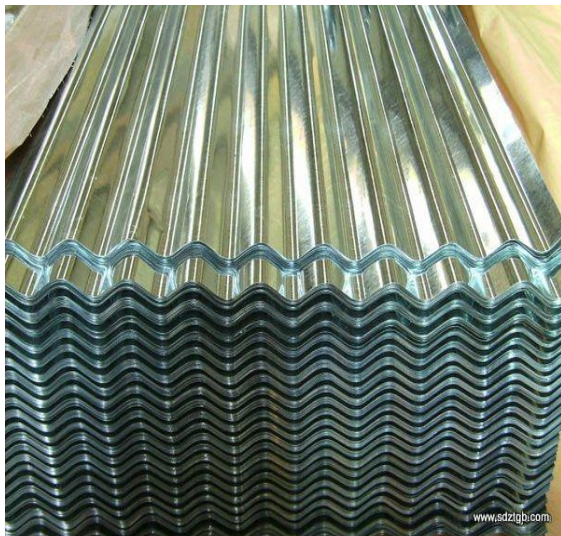
Figure 1a. CGI Sheet Metal

roof structure has been conducted overseas but very few towards Malaysian environment in Malaysia [6-9], (Tamura, et al., 2001, 2009, 2010; Uematsu and Isyumov, 1999). Most of the rural houses are considered as non-engineered structures. Corrugated Galvanized Iron (CGI) sheet metal is commonly used in rural house roofing system. However there are no specific guidance on how the sheet zinc metal are assemble. CGI sheet metal frequently experienced a pull-through failure during the thunderstorm due to uplift forces. According to Mahaarachchi & Mahendran [9] from the field and laboratory investigations have shown that damage of steel roofs has often occurred due to the failures of their connections. From the previous study, a single nail connection can be with stand up to 0.71 kN [10]. In this study, CGI sheet metal was examined under the variation wind load. SAP 2000 software was used to analyse the wind load effect of CGI sheet metal. This study focus on the effect of nail connection spacing on CGI sheet metal until failure. The usual CGI sheet metal and nail that widely used in Malaysia is shown in Fig 1a and Fig 1b. In this study the CGI sheet metal model are examined with various wind speed and spacing of nail connections.

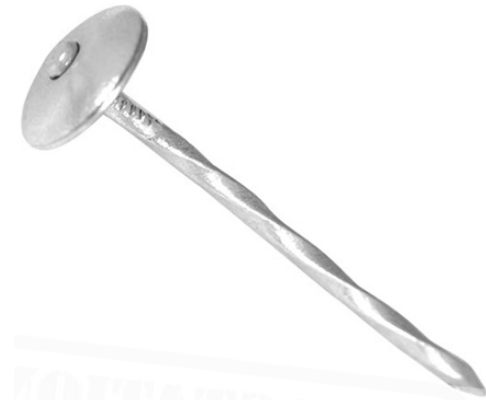
Figure 1b. Nail

Table 1 shows, the value of force of each single point of nail connection for various spacing between nail connections. It clearly shows that as the distance between the connection increases, the force acting on each nail connection increases. From previous study [10] the maximum load before the pull through failure is identify at 0.7 kN. By using interpolation the 0.7 kN force will be estimated occur at the spacing between the nail connection of 480 mm. Consequently, the risk of pull through failure will occur if the spacing is greater than a 480 mm.
